# a living river

CHARTING SANTA CRUZ RIVER CONDITIONS  
DOWNTOWN TUCSON TO MARANA

SUPPLEMENTARY REPORT FOR 2013 TO 2020 WATER YEARS

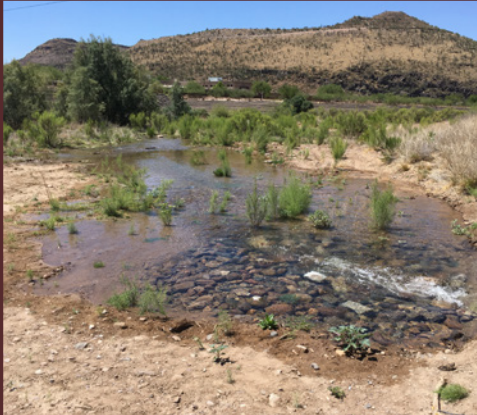
June 2019 Heritage Project

- **New flows near downtown Tucson:** High-quality effluent is released into the Heritage Project reach starting in June 2019. Wetland plants quickly established and dragonflies and other wildlife quickly find the new flows.

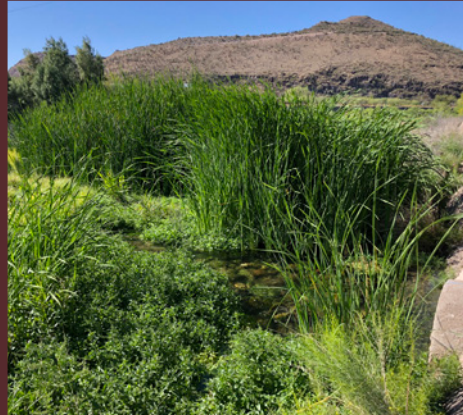
April 2020 Heritage Project

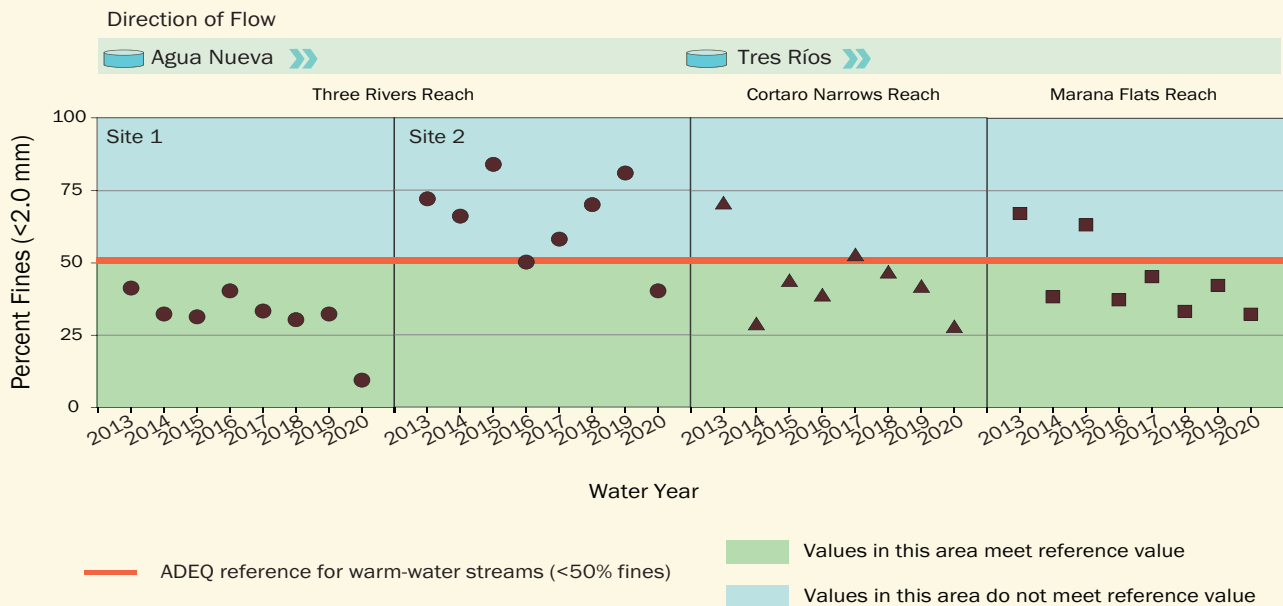
**Percent fines** is an estimate of the portion of the riverbed comprised of small sediments ( $\leq 2$  mm in diameter). ADEQ does not have a standard for rivers dominated by effluent. This assessment uses the reference value for warm-water streams, percent fines  $< 50\%$ .

Percent fines were estimated at four sites where aquatic invertebrate samples were collected. Overall there was a reduction in the percent fines covering the riverbed at these sites, though there was a lot of variation. In 2020, all sites recorded their lowest percentage of fine materials since monitoring efforts began. For unknown reasons, the second site in Three Rivers had a very linear increase in percent fines between 2016 and 2019 prior to decreasing significantly in 2020.

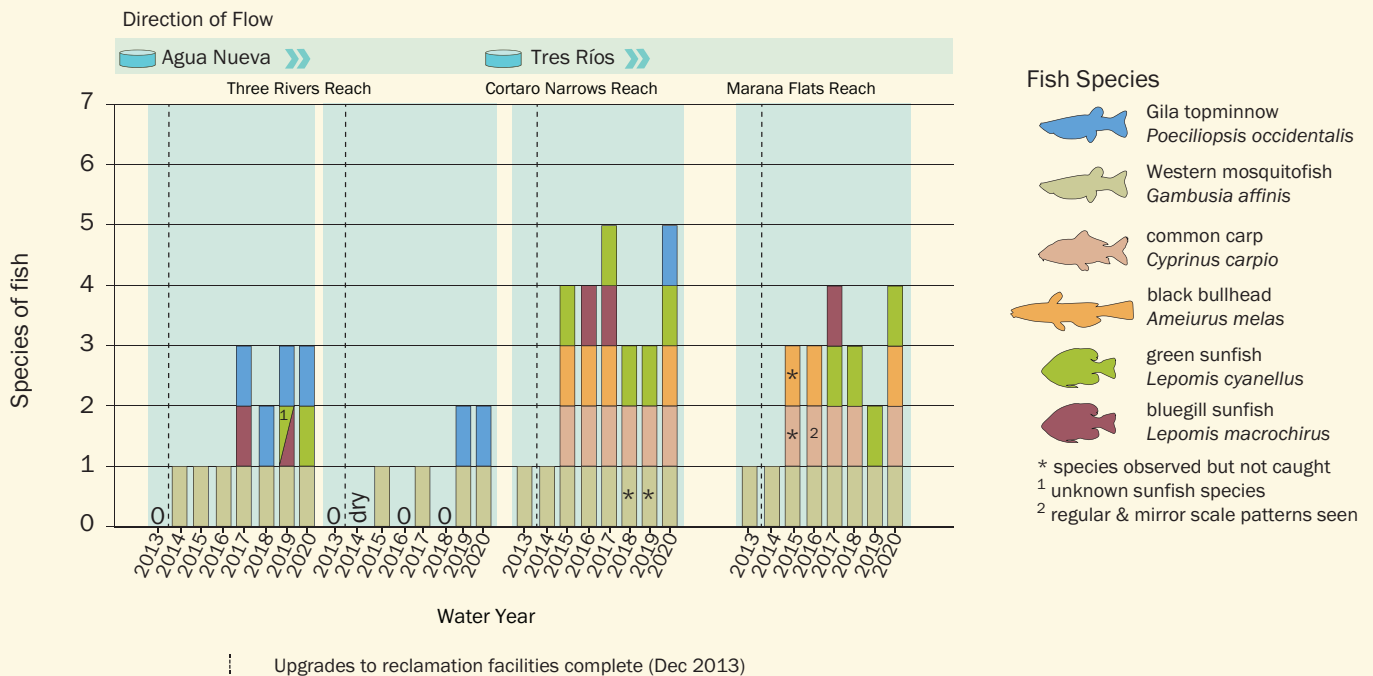
Fish surveys were conducted annually in the fall at the four locations aquatic invertebrates were surveyed. Surveys aim to detect all fish species present at a location, but do not try to assess population numbers. Improvements in water quality have allowed fish to thrive. Overall, number of fish species observed increased from one to six. All are non-native, except for the endangered Gila topminnow, which was found at one site in 2017, expanding to three sites in 2020. Exactly how this native fish returned is unknown. Genetic analysis suggests the Gila topminnow in the river near Tucson are most similar to fish found in the Cienega Creek watershed. One possibility is that the fish may have come down with stormwater flows in the Rillito from Sabino Canyon where the closest population lives.

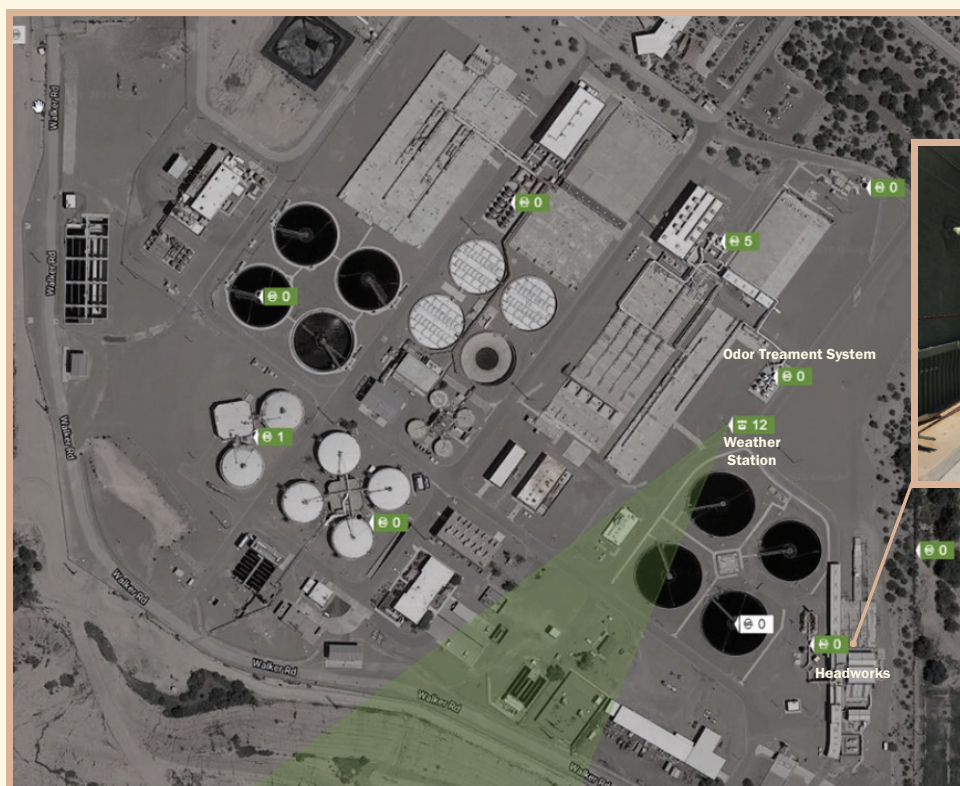
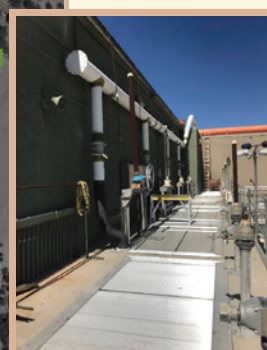
**Monitoring odor at the Tres Ríos Water Reclamation Facility**

Green squares mark locations where odor is monitored continuously. The green “wedge” demonstrates how the weather station can help identify the direction wind would carry any odors escaping from the treatment process. Above photo, new pipes and decking at the headworks were installed in early 2019 to prevent odors from escaping.

Since January 2014, there were no odor complaints at Agua Nueva. Levels of H<sub>2</sub>S at Tres Ríos were also low. However in 2016, there were isolated odor complaints from the people using the adjacent sports park. In 2017, Pima County investigated odors escaping from loose decking near the headworks. Repairs were made and more piping installed to capture foul air. Since project completion in early 2019, Tres Ríos has not received an odor complaint. A Process Optimization Team continuously monitors the odor treatment systems and odor detection equipment at all of the water reclamation facilities to ensure that odor levels remain invisible to the public.
