# a living river

CHARTING SANTA CRUZ RIVER CONDITIONS  
DOWNTOWN TUCSON TO MARANA

SUPPLEMENTARY REPORT FOR 2013 TO 2021 WATER YEARS

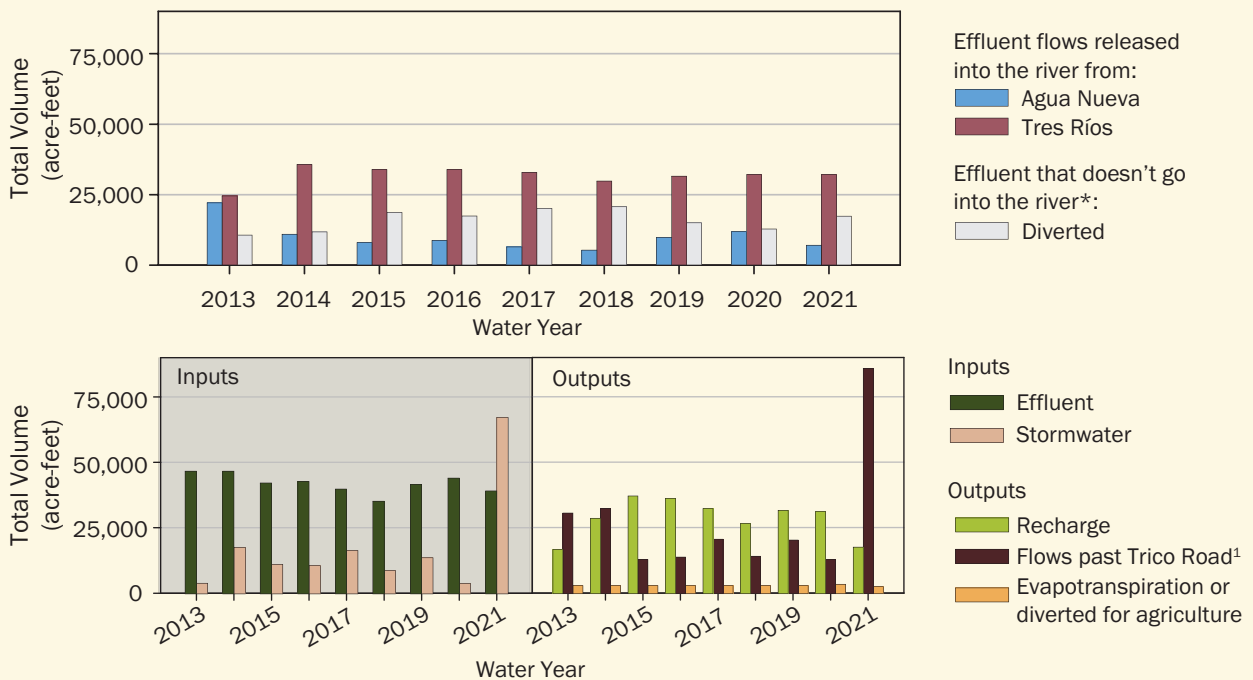
## 2013–2021 WATER BUDGET NORTHWEST TUCSON TO MARANA REACH

with water one foot deep. In this 23-mile stretch of river there are two managed recharge projects. Total recharge volume is calculated for effluent only and does not include stormwater. On days when the flow in the river includes stormwater, recharge is assumed to be zero for accounting purposes. Recharge is calculated by subtracting the sum of the flow past the Trico Road gage, evapotranspiration, and off-channel diversions from the total water released into the river.

\* Includes effluent that is diverted from Agua Nueva either to the reclaimed system for irrigation or to recharge basins located outside the river channel.  
<sup>1</sup> Excluding days with stormwater, the volume of effluent flowing past Trico Road is: 2013 = 26,800 AF; 2014 = 13,400 AF; 2015 = 2,100 AF; 2016 = 3,800AF; 2017 = 3,700 AF; 2018 = 6,000 AF; 2019 = 6,000 AF; 2020 = 10,800 AF, 2021 = 16,800 AF

Recharge is calculated by subtracting the sum of the flow past the gage at Congress Street and evapotranspiration, from the total water released into the river.

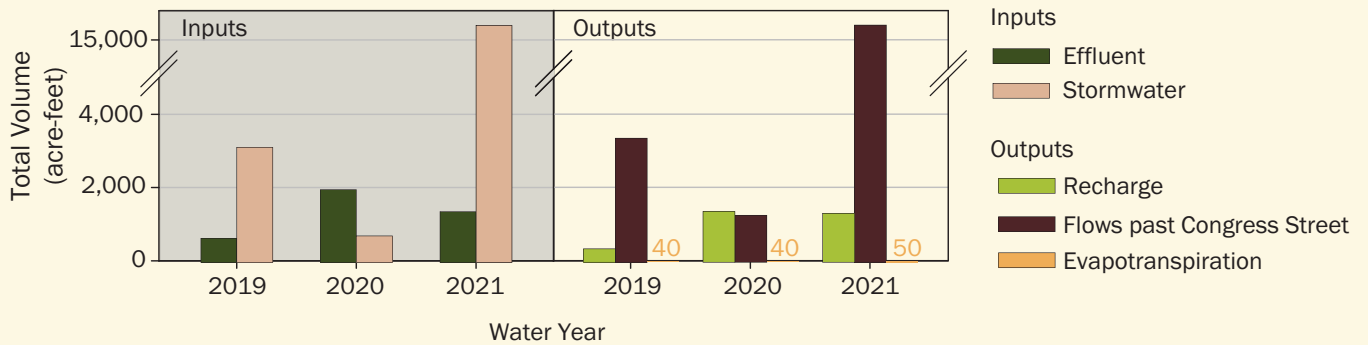
### 2019–2021 WATER BUDGET HERITAGE PROJECT REACH

Tucson Water started adding effluent to the Heritage Project reach near downtown in June 2019. Effluent provides most of the flow in the river near downtown. This was especially true in 2020 when stormwater flows were minimal. Much of the effluent sinks into the riverbed to recharge the aquifer prior to reaching Congress Street. The volumes of water used by wetland vegetation are considered as estimated constants in recharge calculations. Starting in 2021, water from the [Conservation Effluent Pool](#) provides water to support the riparian and wetland vegetation in this reach, although strong monsoon activity in 2021 also contributed a high volume of stormflow.

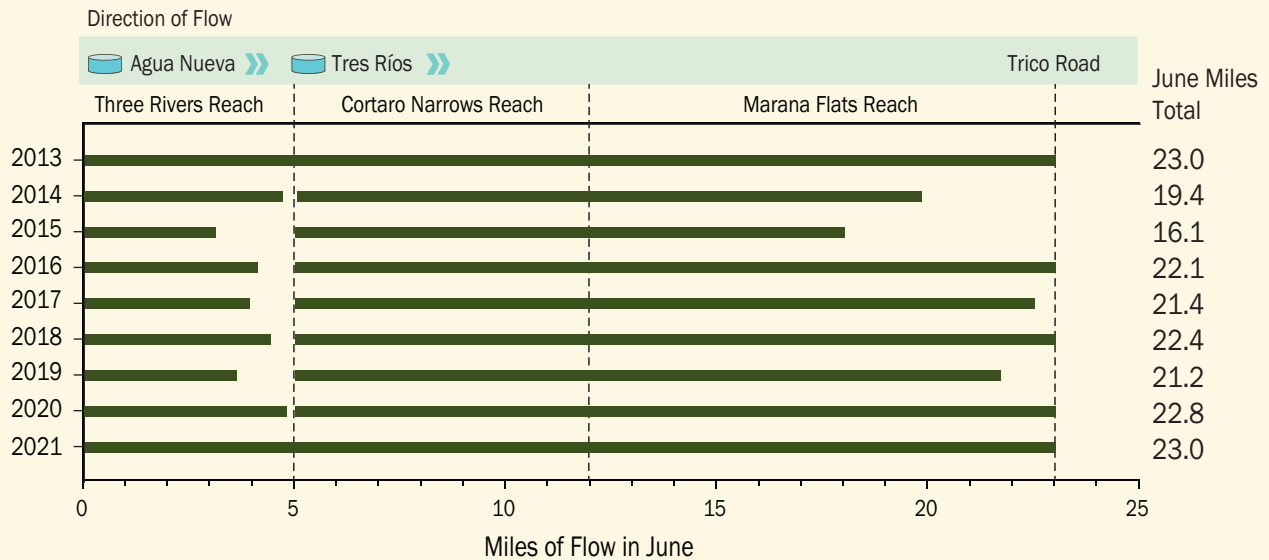
**Miles of flow in June** from Agua Nueva outfall to Trico Road prior to the monsoon season determines the minimum extent of flow in each reach during the driest time of year. This is typically measured on one morning in mid-June. **Flow at Trico Road** estimates daily changes in maximum flow extent by counting the “dry days,” or number of days with no streamflow at Trico Road, located at the downstream end of the study area.

Flow extent decreased and was more variable after the December 2013 upgrades. In June 2013, the river flowed uninterrupted to the end of the 23-mile study area, and continued another 5 miles further into Pinal County. Uninterrupted river flow occurred again in June 2021 for the first time since 2013, with the river reaching past the 23-mile study area. In other years, dry river stretches of varying lengths have formed between Agua Nueva and Tres Ríos reclamation facilities, and upstream of Trico Road.

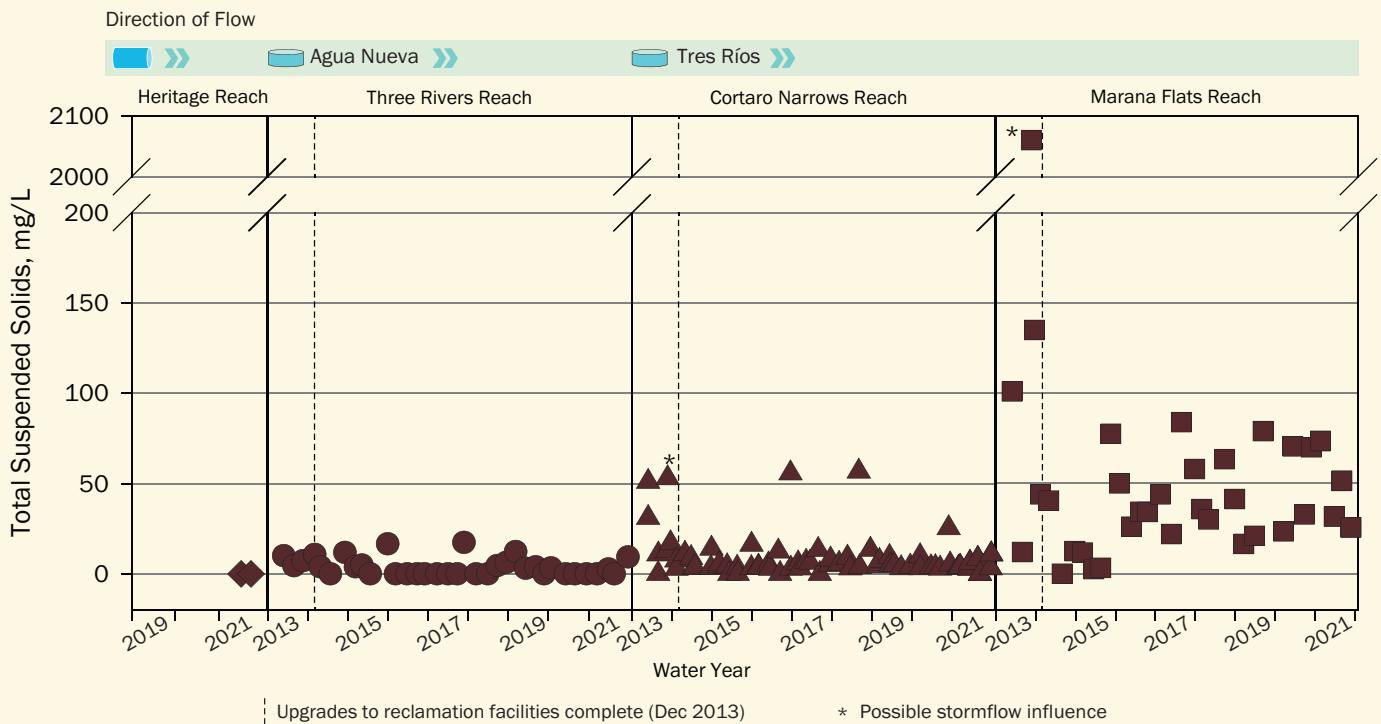
Levels of total suspended solids naturally increase during flooding conditions with extra stormwater. The Arizona Department of Environmental Quality (ADEQ) does not have a standard for total suspended solids. The concentration of total suspended solids in each reach from the 2013 water year serves as a baseline.

Total suspended solids (TSS) were measured a total of 139 times during normal flow conditions. Levels of TSS are lowest and least variable in Three Rivers. Cortaro Narrows had decreased levels of TSS since 2013, with only occasional high levels observed. Marana Flats had the most variable levels of TSS. From 2014–2015, TSS briefly decreased in Marana Flats after the upgrades were complete. After 2015, TSS levels in Marana Flats increased though remained lower than levels recorded before the upgrade.

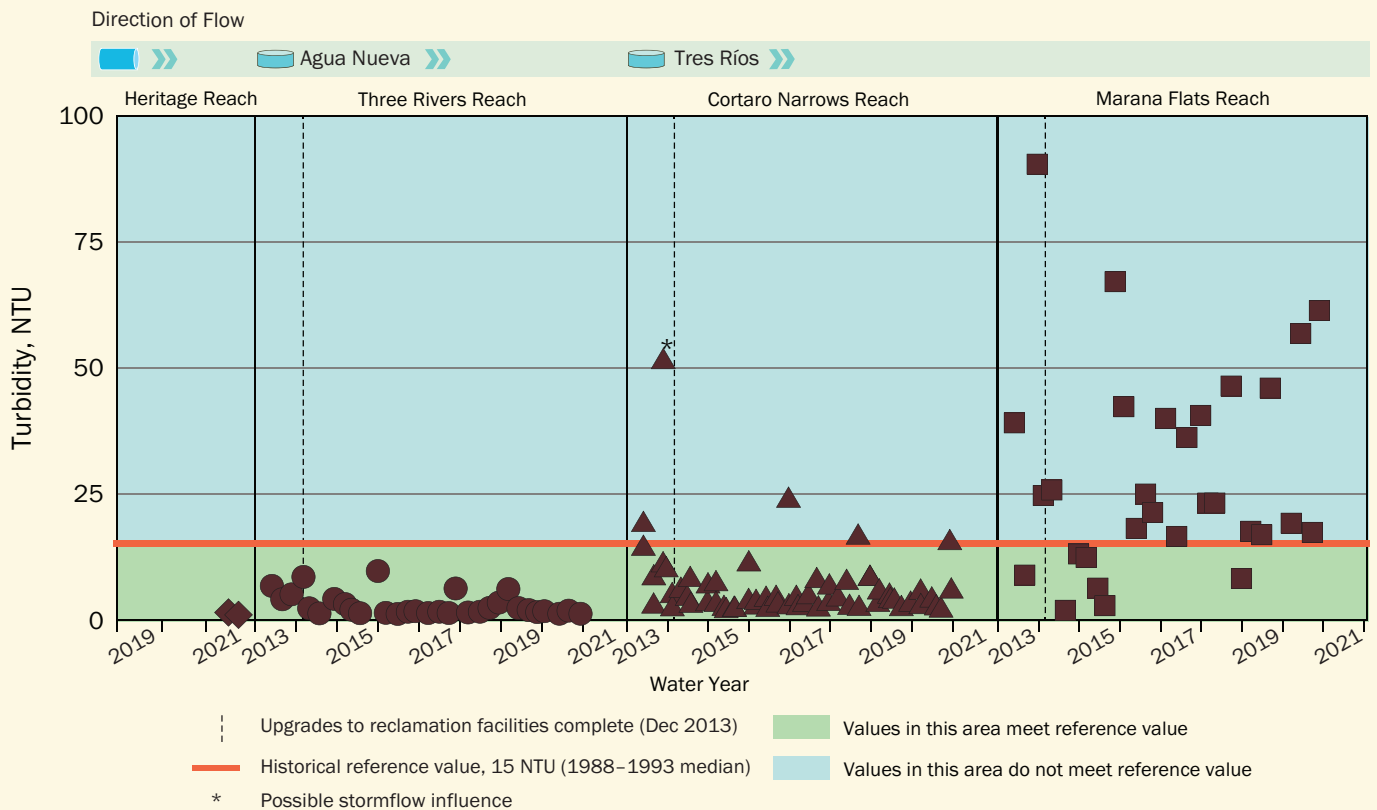
Turbidity Units (NTU). High NTU indicates the water is cloudy and hard to see through. The 1988–1993 median level of turbidity in the Cortaro Narrows reach was 15 NTU. ADEQ does not have a standard for turbidity, so this assessment uses 15 NTU as a historical reference value. This is slightly higher than a typical value of 10 NTU for a river with normal base flow and no stormwater influence.

Turbidity was measured throughout the year at several locations for a total of 139 times. Overall, the reference value was met 108 times (78%). Average turbidity within Three Rivers and Cortaro Narrows has decreased since the 2013 upgrades were complete; both have averages below 10 NTU. Although average turbidity decreased in Marana Flats following the upgrades, values have been higher and most variable in this reach since 2016.

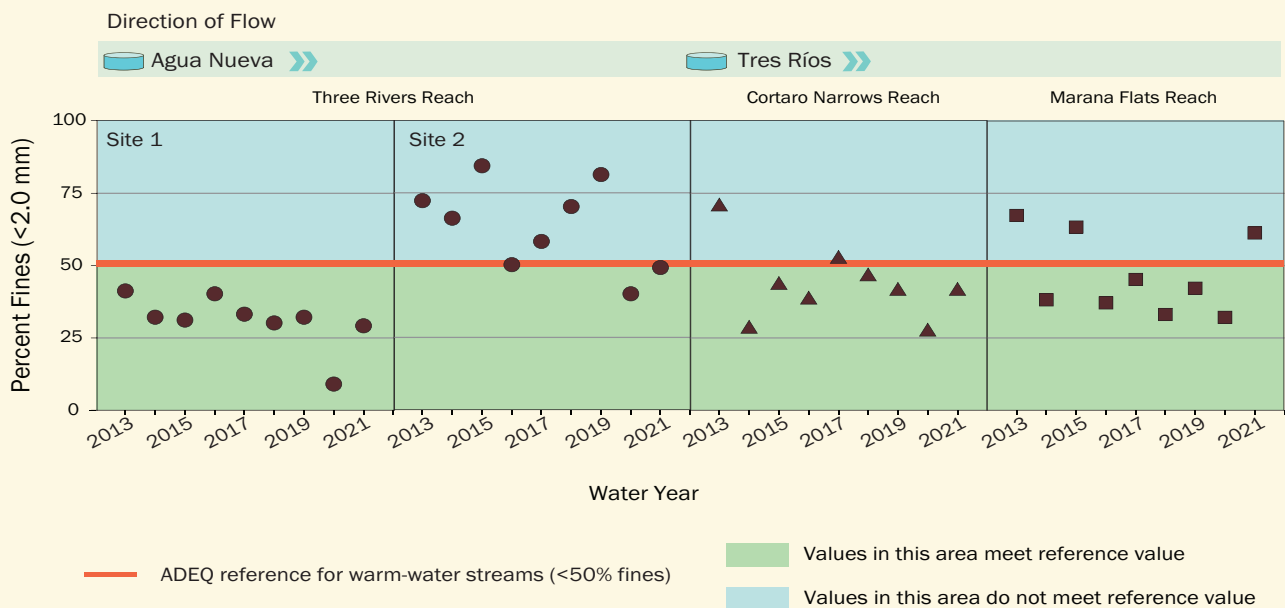
**Percent fines** is an estimate of the portion of the riverbed comprised of small sediments ( $\leq 2$  mm in diameter). ADEQ does not have a standard for rivers dominated by effluent. This assessment uses the reference value for warm-water streams, percent fines  $< 50\%$ .

Percent fines were estimated at four sites at the time aquatic invertebrate samples were collected in May of each year. Overall there was a reduction in the percent fines covering the riverbed at these sites, though there was a lot of variation. In 2020, all sites recorded their lowest percentage of fine materials since monitoring efforts began. For unknown reasons, the second site in Three Rivers had a very linear increase in percent fines between 2016 and 2019 prior to decreasing significantly in 2020. All sites showed an increase again in 2021, although the second site at Three Rivers did not reach the same level as before. Marana Flats had the highest percentage at this site since 2015.

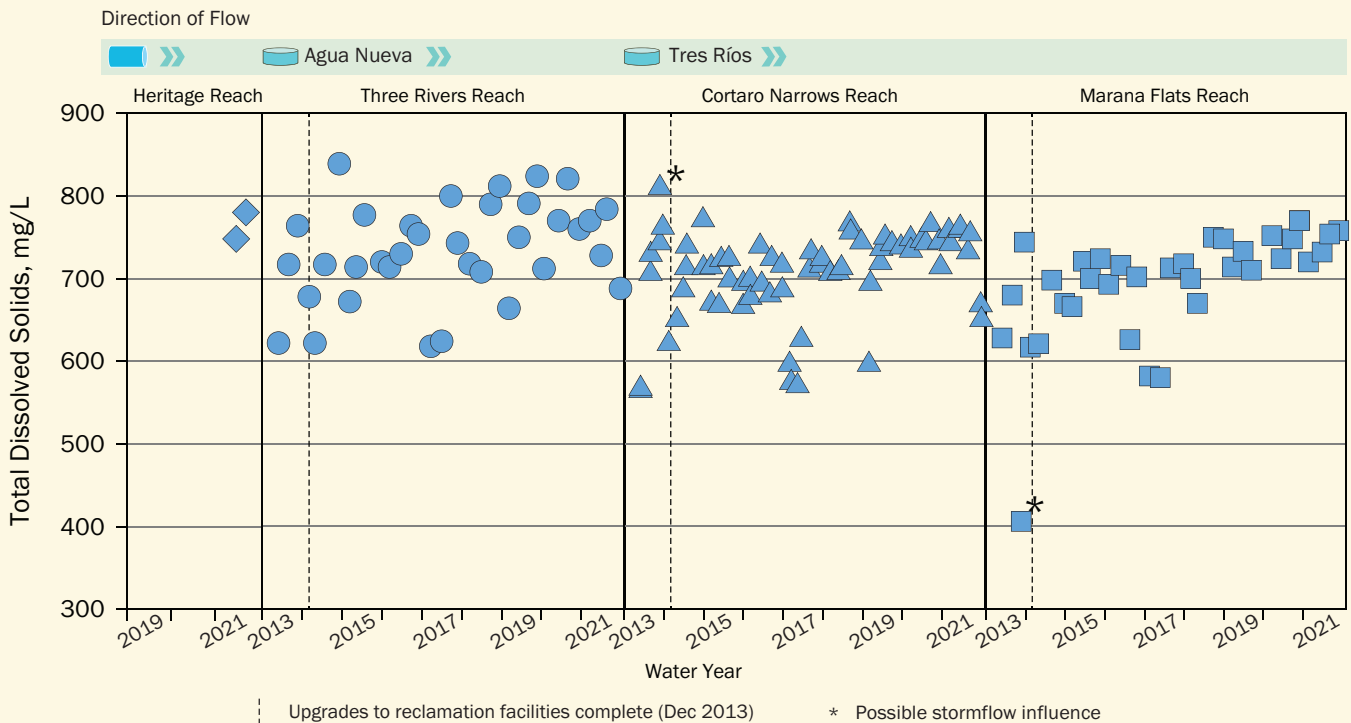
greater TDS, mostly in form of dissolved salts, than the local groundwater. Because there is no standard for TDS (often standards are for individual elements that contribute to TDS), the results from the 2013 water year will serve as a baseline. Freshwater generally has TDS <1,000 mg/L and stormwater generally has low levels of TDS.

Total dissolved solids (TDS) were measured 138 times. Overall, levels of TDS were similar in all three reaches. Generally TDS hasn't changed very much, though variability in TDS levels decreased in 2015 and 2016 for unknown reasons. The lowest measure of TDS was in Marana Flats. This sample was collected on a day where there was possible stormwater influence. Thus, the addition of water with lower TDS levels may have diluted the levels in this reach of the Santa Cruz River. Samples of stormwater are collected upstream of Agua Nueva when possible. Four samples collected (one each year during the summer monsoon in 2013–2016) averaged 280 mg/L.

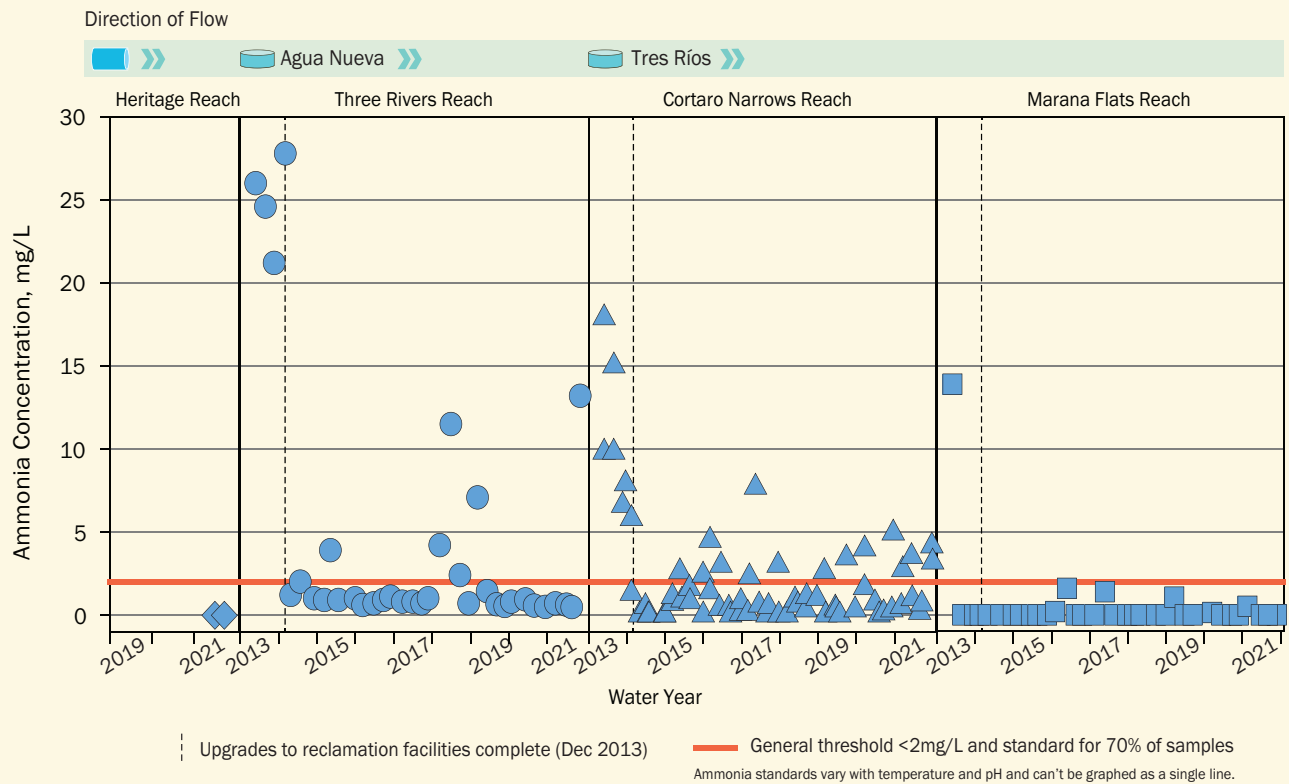
**Ammonia** ( $\text{NH}_3$ ) is one form of nitrogen that can be toxic to fish and amphibians. Even at low concentrations, ammonia can reduce hatching success, among other impacts. The ADEQ standard for ammonia varies with pH (level of acidity) and temperature. As pH and temperature increase, the toxicity of ammonia increases; thus, the acceptable level of ammonia decreases with high pH and temperature. A general threshold often used is  $<2 \text{ mg/L}$  to avoid toxic conditions.

Ammonia was measured 137 times along the river. Overall the standard was met 100 of the 119 times (73%). The standard varies with pH and temperature, but was  $<2 \text{ mg/L}$  for 70% of the samples. Levels of ammonia have dropped significantly after the upgrade was complete in 2013. Levels of ammonia also decreased with distance from the reclamation facilities, as it converts into other forms of nitrogen while moving downstream. Measured at four locations (two locations in Cortaro Narrows reach), average ammonia concentrations declined from a toxic  $13 \text{ mg/L}$  in 2013 to  $1 \text{ mg/L}$  in 2014–2021.

Occasional elevated levels of ammonia are observed near the Agua Nueva and Tres Ríos Water Reclamation Facilities. Removing ammonia is a complex process. The facilities use a five-stage process that features alternating oxygenated and oxygen-free zones. To prevent any occasional spikes in ammonia, Pima County regularly optimizes processes to better maintain the delicate balance of oxygen needed for maximum ammonia removal.

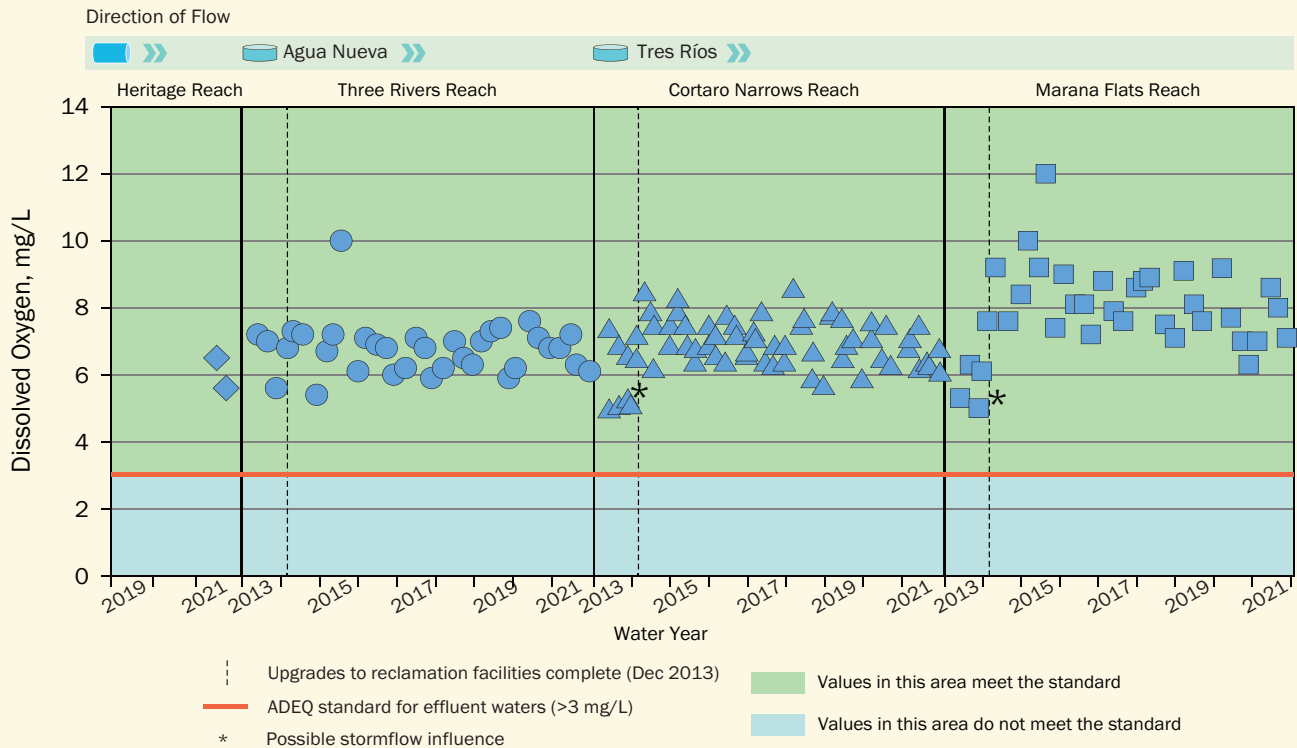
temperature, decay of organic materials, and time of day. ADEQ sets the minimum standard for dissolved oxygen in streams dominated by effluent at 3 milligrams per liter (mg/L) during the day (3 hrs after sunrise to sunset).

Dissolved oxygen was measured 137 times along the river. All of the samples met the standard for dissolved oxygen (100%). Levels of dissolved oxygen stayed fairly constant in Three Rivers and Cortaro Narrows. However, Marana Flats saw an increase in dissolved oxygen after the facility upgrades were completed.

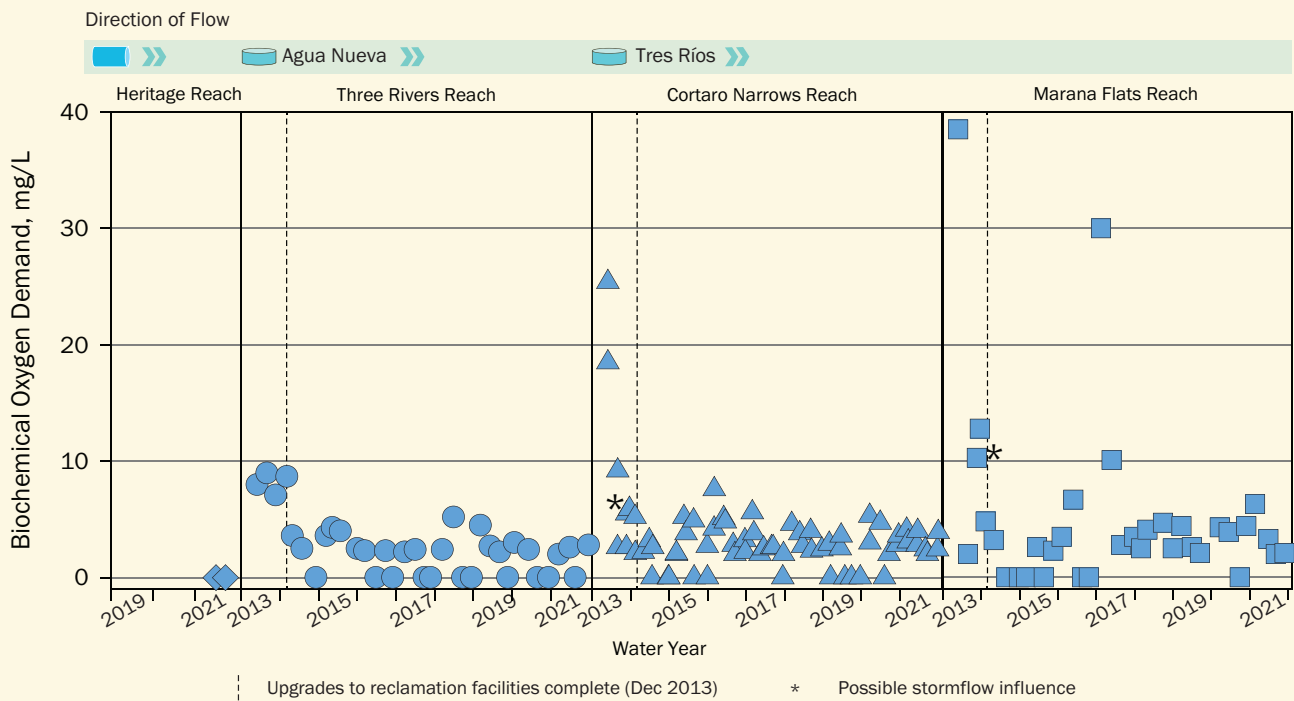
so numerous that they consume much of the dissolved oxygen and deprive other aquatic animals of the oxygen they need to survive. Though there are standards for BOD in the wastewater reclamation process, there is no standard for BOD in rivers. The results from the 2013 water year will serve as a baseline.

Biochemical oxygen demand was measured 139 times along the river. BOD has decreased since the upgrades to the reclamation facilities were completed. The high levels observed in Cortaro Narrows are absent after the 2013 water year. This pattern is generally the same in Marana Flats. However, for reasons unknown, measures of BOD in the first half of 2017 were similar to the high levels observed during the 2013 baseline.

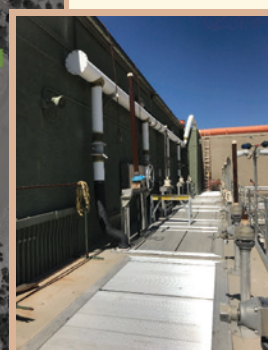
**Monitoring odor at the Tres Ríos Water Reclamation Facility**

Green squares mark locations where odor is monitored continuously. The weather station can also help identify the direction wind would carry any odors escaping from the treatment process (illustrated here with green “wedge”). Above photo, new pipes and decking at the headworks were installed in early 2019 to prevent odors from escaping.

systems and advanced monitoring equipment, coupled by a computer program that can track odor trajectories, help prevent **odor at the water reclamation facilities** from leaving the site. Minimizing both the extent and intensity of disagreeable odors coming from the facilities was one of the goals of the reclamation facility upgrades.
