CHARTING SANTA CRUZ RIVER CONDITIONS  
NORTHWEST TUCSON TO MARANA—2019 WATER YEAR

SUPPLEMENTARY REPORT FOR 2013 TO 2019 WATER YEARS

# THE SANTA CRUZ RIVER A LIVING ECOSYSTEM

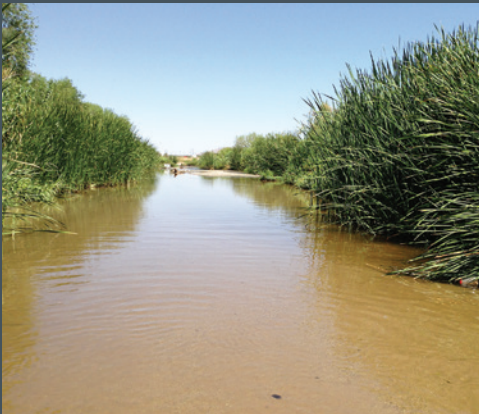
Cloudy water, before upgrade

- **Water clarity much improved:** Sediments and other particles carried in the water decreased, resulting in clear river water on normal non-flooding days. Elevated sediment levels in the water can increase water temperature, thereby decreasing available dissolved oxygen.

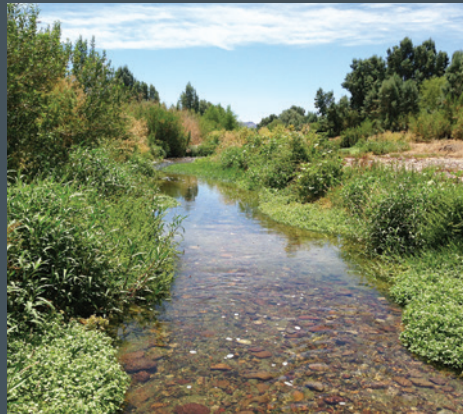
Clear water, after upgrade

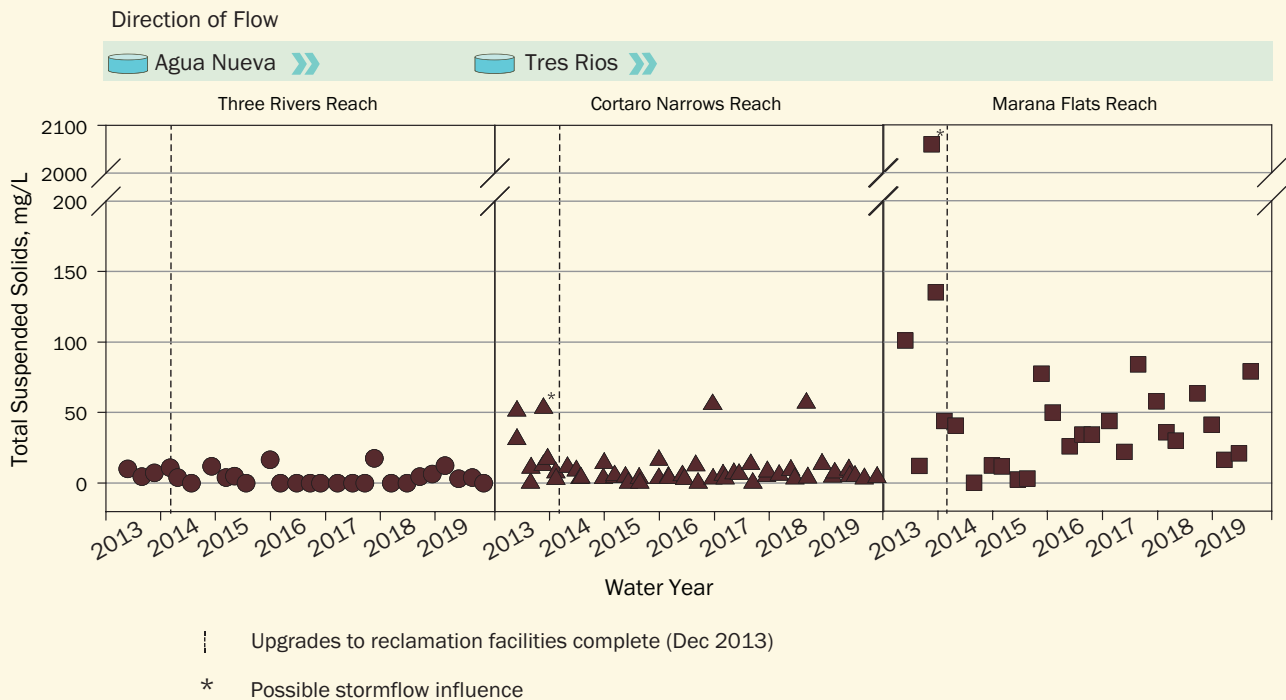
**Total suspended solids** is an estimate of the number of particles in the water, or the intensity of the “dust storm.” ADEQ does not have a standard for total suspended solids. The average concentration of total suspended solids in each reach from the 2013 water year serve as a baseline.

Total suspended solids (TSS) was measured a total of 106 times during normal flow conditions. Levels of TSS decreased in Cortaro Narrows and Marana Flats after the upgrades were complete. Levels of TSS were similar in all three reaches in 2014 and 2015. Since 2016, Marana Flats has increased, though levels were still lower than the 2013 baseline. Stormwater is expected to have greater levels of TSS. Samples of stormwater are collected upstream of Agua Nueva when possible. Four samples collected (one each year during the summer monsoon for 2013–2016) had TSS concentrations ranging from 1,050 to 46,300 mg/L and were higher than levels on normal flow conditions.

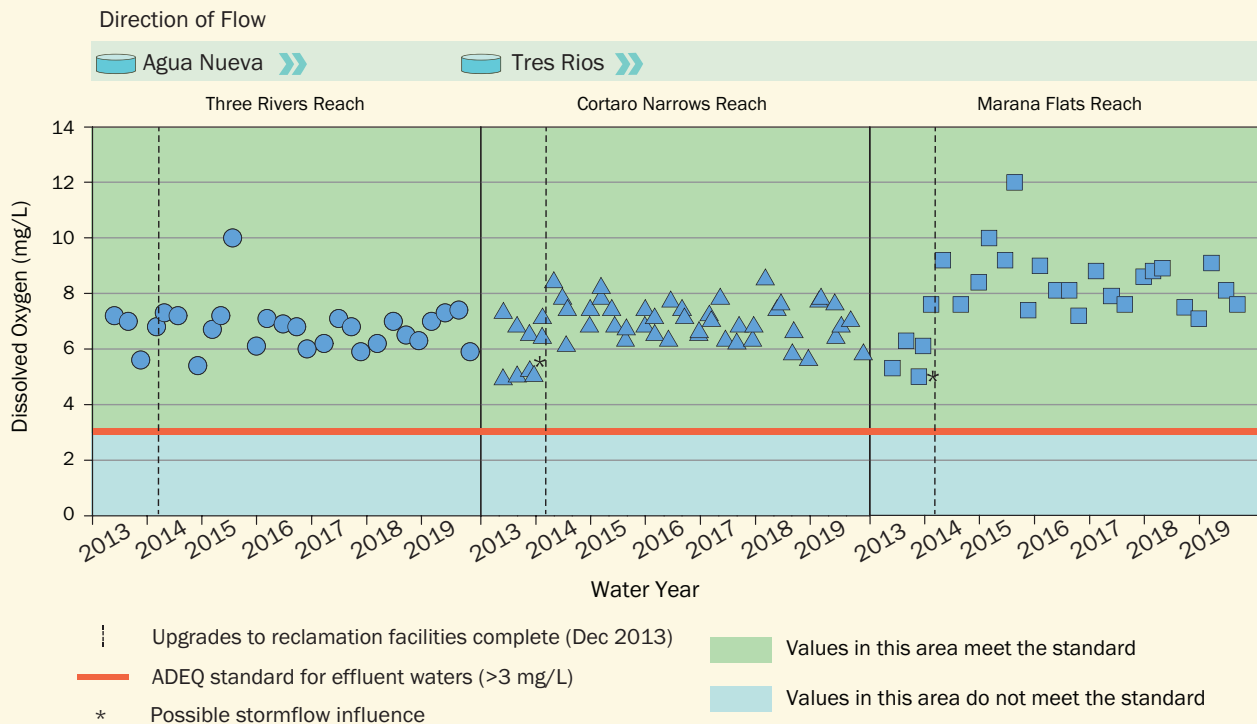
levels, shading, water temperature, and time of day. ADEQ sets the minimum standard for dissolved oxygen in streams dominated by effluent at 3 milligrams per liter (mg/L) during the day (3 hrs after sunrise to sunset).

Dissolved oxygen was measured 106 times along the river. All of the samples met the standard for dissolved oxygen (100%). Levels of dissolved oxygen stayed fairly constant in Three Rivers and Cortaro Narrows. However, Marana Flats saw an increase in dissolved oxygen after the facility upgrades were completed.

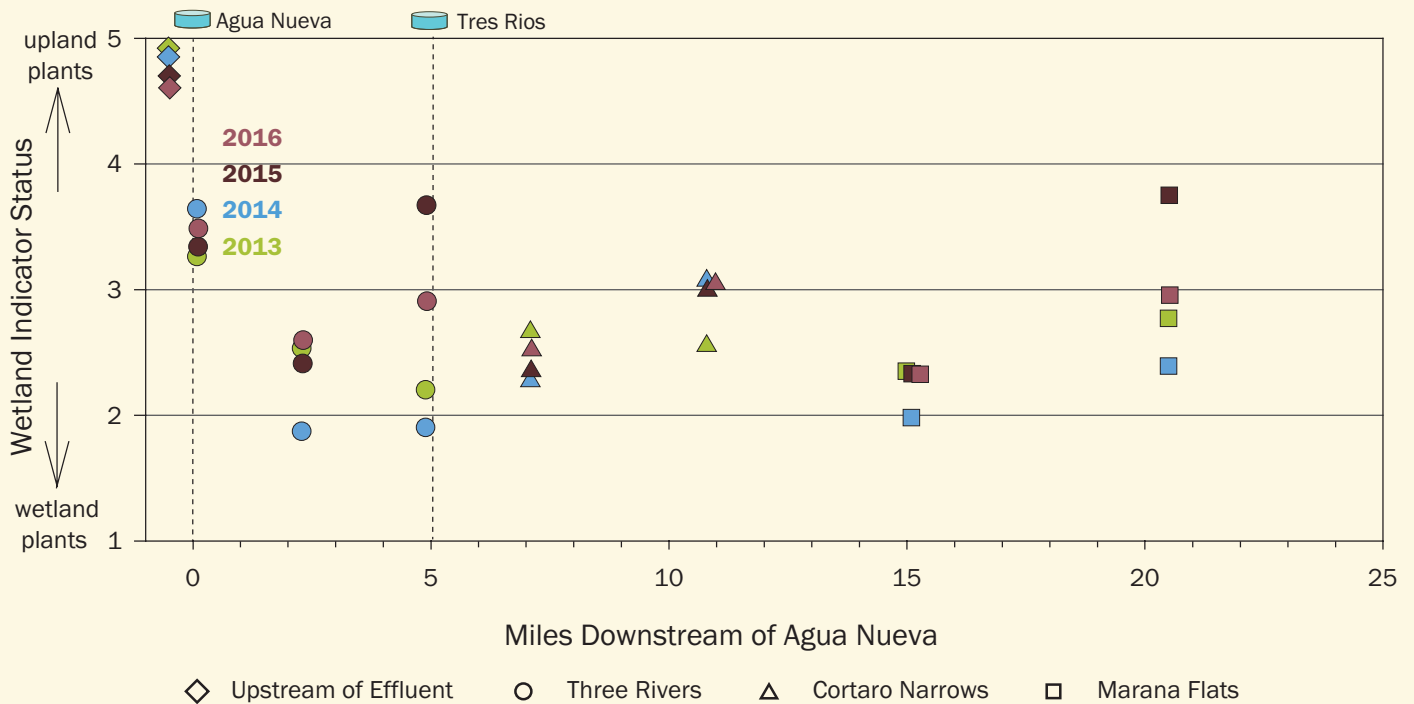
(>4) indicate that the majority of plants are upland plants like burrobrush and different grasses; these do not depend on consistent presence of water in the river and usually are not found in wetlands. Results from the 2013 water year will serve as a baseline to help track future changes in wetland plants.

**Not measured in 2017–2019.** Wetland indicator status (WIS) was determined for eight total locations along the river. Overall, scores have remained similar at most sites. Scores averaged 2.7 downstream of Agua Nueva. This suggests greater presence of wetland plants instead of upland plants as the river flowed away from the reclamation facilities. Just upstream of the study area, a reference site had the highest scores and was dominated by upland plants. Two sites (approximately 5 and 20 miles downstream) appeared to shift toward more upland plants with increased scores in 2015. This may be in part explained by changes in flow extent, as these sites experienced dry conditions more frequently in water year 2015. However, these same sites were wet again when surveyed in 2016, and stream-side plants shifted back toward wetland plants.

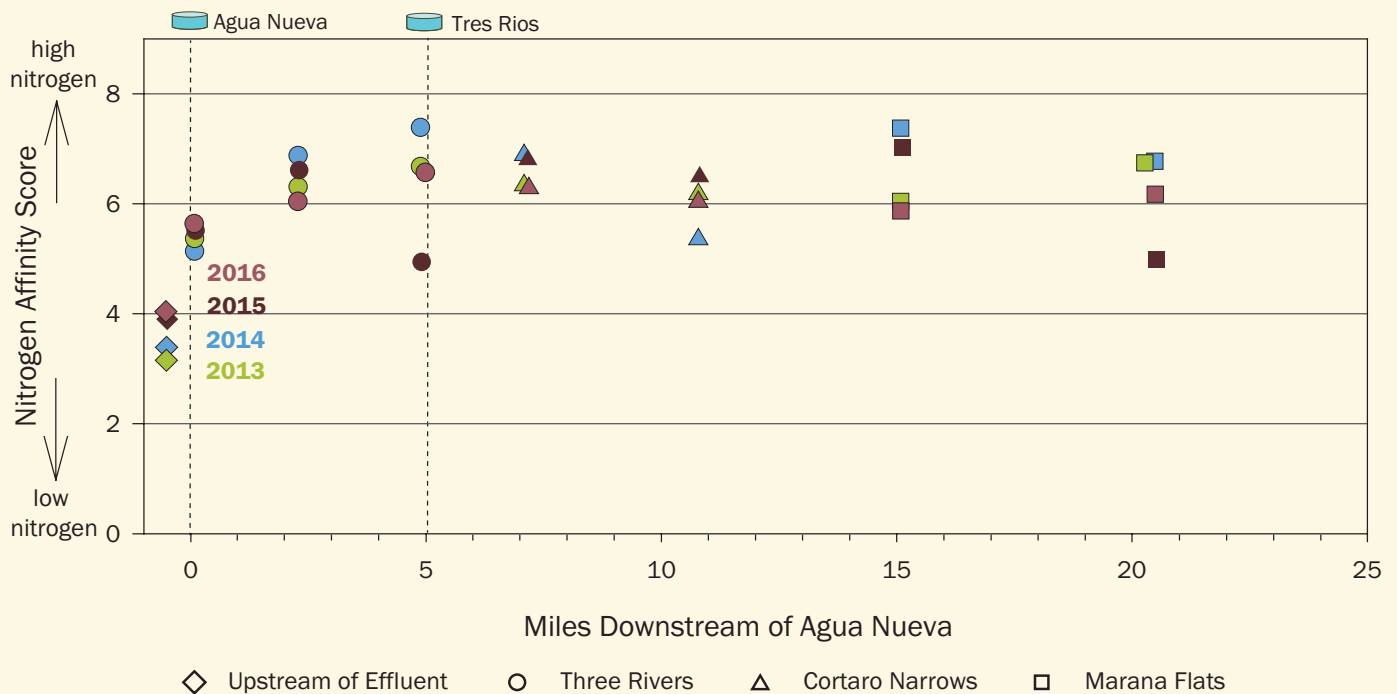
and different grasses. High scores (>5) indicate that the majority of plants grow well with high levels of nitrogen, like cattails and common sunflowers. Changes in nitrogen affinity scores likely reflect changes in water quality, either an increase or decrease in nutrients in the water. Results from the 2013 water year will serve as a baseline.

**Not measured in 2017–2019.** Nitrogen affinity score was determined for eight total locations along the river. Overall, scores have remained similar at most sites. Scores averaged 6.2 downstream of Agua Nueva. This suggests that stream-side plants that grow well in high nitrogen environments were most common immediately downstream of the reclamation facilities. Just upstream of the study area a reference site had the lowest scores and was dominated by plants that grow well with low levels of nitrogen. Two sites (approximately 5 and 20 miles downstream) appeared to shift toward more low-nitrogen plants in 2015. Though we may expect this shift from reduced nutrient pollution, reduction in water presence and soil moisture may be the bigger factor. Both of these sites experienced dry conditions more frequently in water year 2015 and were dry at time of survey in 2015. These same sites shifted back towards nitrogen-loving plants in 2016, when water was present again at time of survey. So both nitrogen affinity and wetland indicator seem to indicate presence of permanent water in the channel or high soil moisture. This is supported by a high correlation of the nitrogen scores with wetland scores; plants with high nitrogen scores had very low wetland scores, or more simply, the wetland plants in our area love nitrogen.

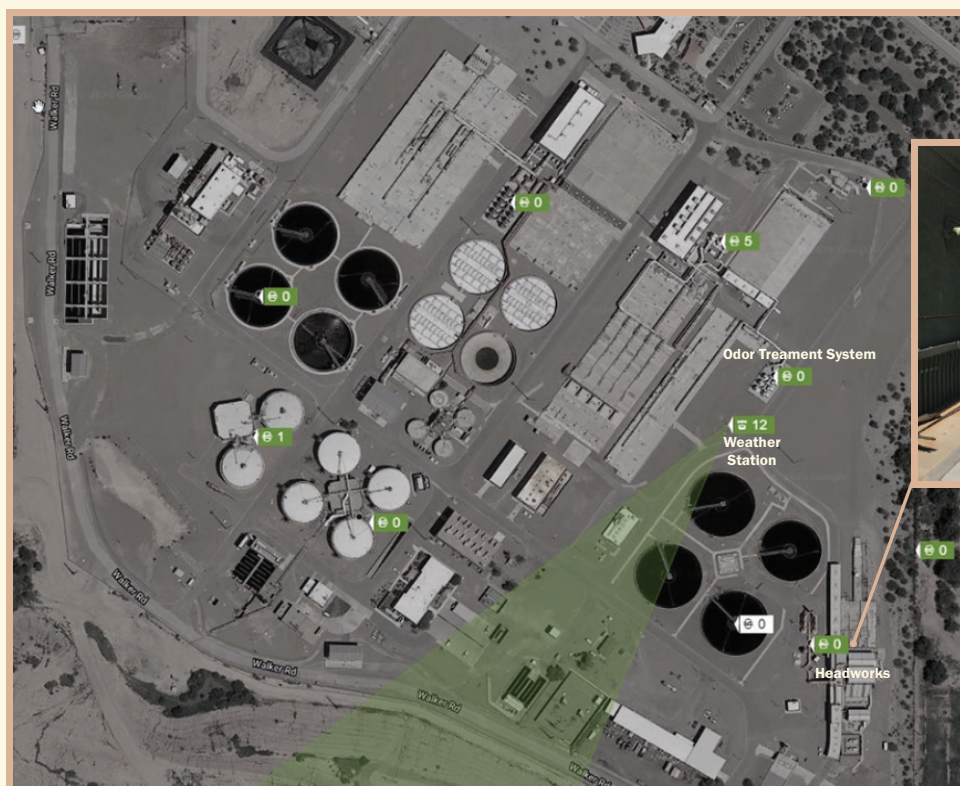
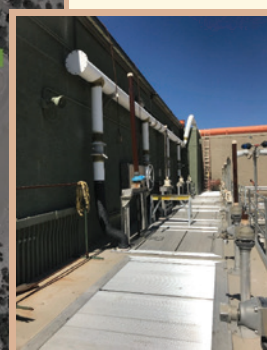
**Monitoring odor at the Tres Ríos Water Reclamation Facility**

Green squares mark locations where odor is monitored continuously. The green “wedge” demonstrates how the weather station can help identify the direction wind would carry any odors escaping from the treatment process. Above photo, new pipes and decking at the headworks were installed in early 2019 to prevent odors from escaping.

Since January 2014, there were no odor complaints at Agua Nueva. Levels of  $H_2S$  at Tres Ríos were also low. However in 2016, there were isolated odor complaints from the people using the adjacent sports park. In 2017, Pima County investigated odors escaping from loose decking near the headworks. Repairs were made and more piping installed to capture foul air. Since project completion in early 2019, Tres Ríos has not received an odor complaint. A Process Optimization Team continuously monitors the odor treatment systems and odor detection equipment at all of the water reclamation facilities to ensure that odor levels remain invisible to the public.
