CHARTING SANTA CRUZ RIVER  
CONDITIONS  
NOGALES WASH TO AMADO

WATER YEAR  
**2021**

SUPPLEMENTARY REPORT  
2008 TO 2021  
WATER YEARS

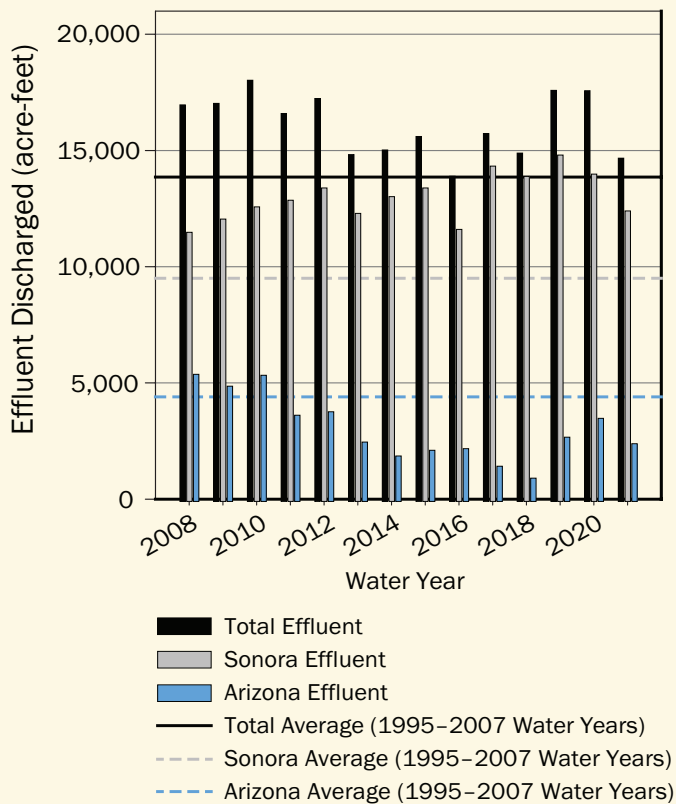
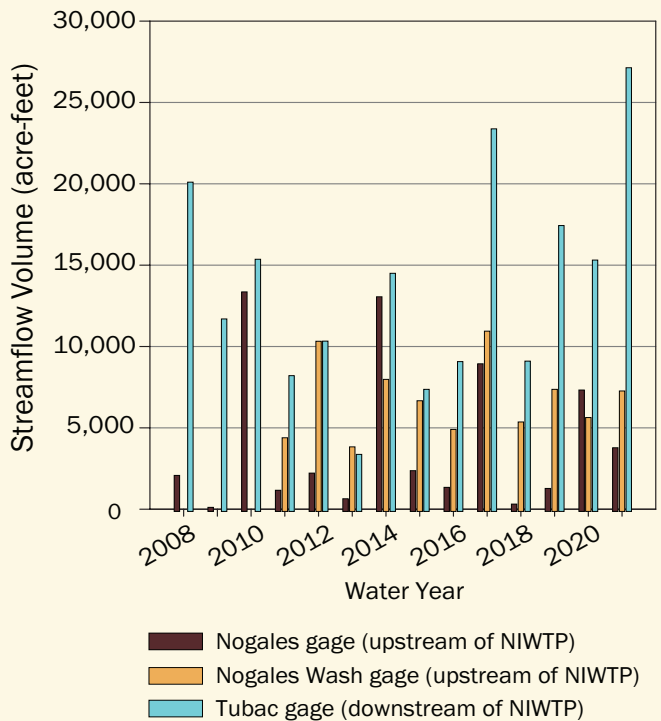
The total volume of effluent released annually into the river has varied, but remained above or at the average released between 1995 and 2007 water years. Between 2013 and 2018, the volume released decreased by an average of 2,000 acre-feet (over 650 million gallons). This represents

about a 12% decrease compared to 2008. Although diversions of wastewater to the Los Alisos Treatment plant in Nogales, Sonora began in 2012, this decrease in effluent volume appears to result from reduced volume of wastewater attributed to Nogales, Arizona. In 2019 and 2020, the total effluent released returned to levels comparable to 2008. Exact reasons for this increase are unknown, though frequent failure of pumps diverting flows to the Los Alisos Treatment Plant in the last couple of years is likely one factor. The increased volume was temporary, and 2021 releases returned to a lower level similar to what was seen between 2013 and 2018.

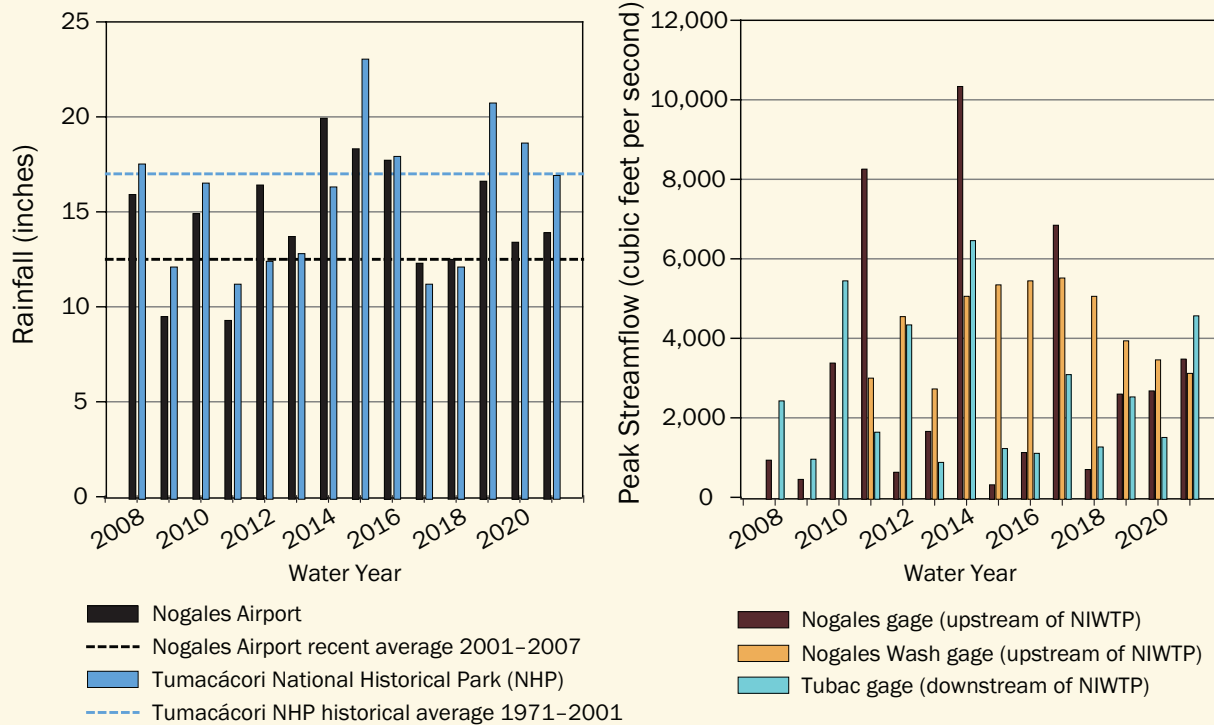
Streamflow is measured daily in Tubac, near the international border, and along Nogales Wash (since 2011). Overall, total volume of streamflow has been variable at all three locations. The greatest total volume of streamflow was measured in

Tubac in the 2021 water year, with most streamflow occurring during the summer monsoons.

Total rainfall has hovered around the recent average at Nogales Airport. Sixteen miles to the northwest, rainfall near Tumacácori National Historical Park has generally been lower than the historical average in this area. Rainfall is spatially variable, and other stations not included in the chart had as high as 20 inches of monsoon rainfall in 2021.

Peak streamflow has varied with location. Flooding conditions have often been higher upstream of the treatment plant than in Tubac with the largest flood recorded at the Nogales gage near the international border. Flows in Tubac have been variable, with the highest peak flow occurring in 2014. Between 2014 and 2018, peak streamflow in Nogales Wash was fairly stable; although it has decreased in the last three years.

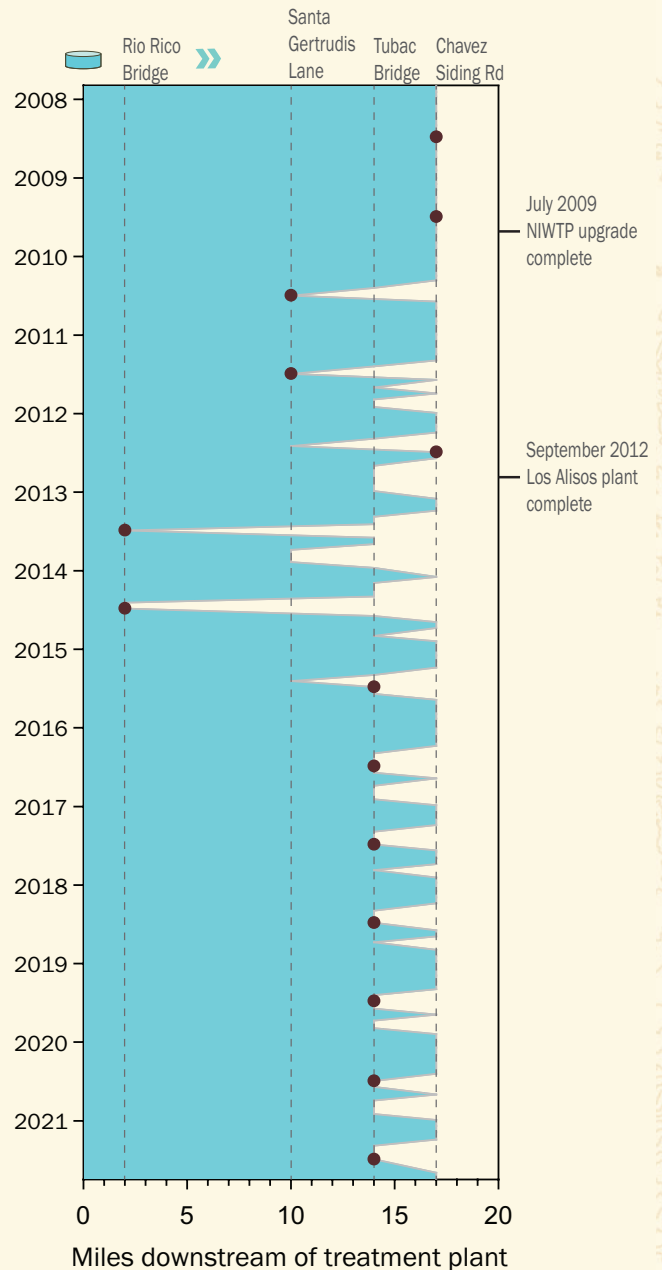
Prior to 2010, the river flowed 17 miles from the treatment plant to the Amado reach, even in June. Since the volume of effluent released into the river did not significantly decrease after the 2009 upgrade, increased recharge from improved water quality is likely a major factor for the decreased flow extent in 2010 and 2011. The shortest measures of flow extent were observed in 2013 and 2014. This coincides with the start of wastewater diversions to the Los Alisos wastewater facility in Sonora, Mexico which began in 2012. However, the reductions in total volume of effluent released into the river between 2013 and 2018 are largely attributed to decreased wastewater coming from Nogales, Arizona (see Streamflow and Rainfall). Since 2014, flow extent has increased and stabilized, reaching at least 14–17 miles at different times through the year. The June flows have consistently reached at least 14 miles during this time as well.

Minimum flow measured once monthly  
 Minimum flow in June

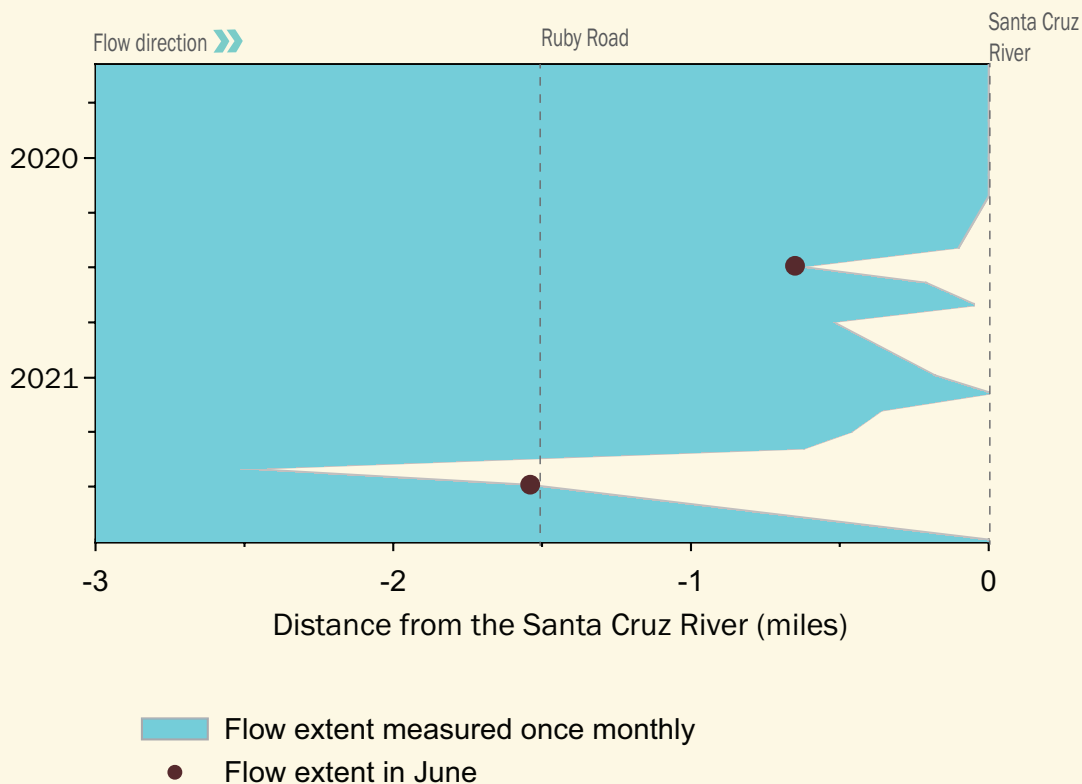
Between 2008 and 2019, Nogales Wash has had water during all but three monthly visits to the monitoring site at Ruby Road. Dry conditions were observed only during June 2011, July 2013, and June 2014.

Starting in July of 2019, Friends of the Santa Cruz River has tracked flows all the way to the confluence with the Santa Cruz River. Though initially stable, flow extent has been more variable since 2020 and does not always reach the river. In May of 2021 the flow retreated as far back as 2.5 miles from the river and the Ruby Road site was dry two months in a row.

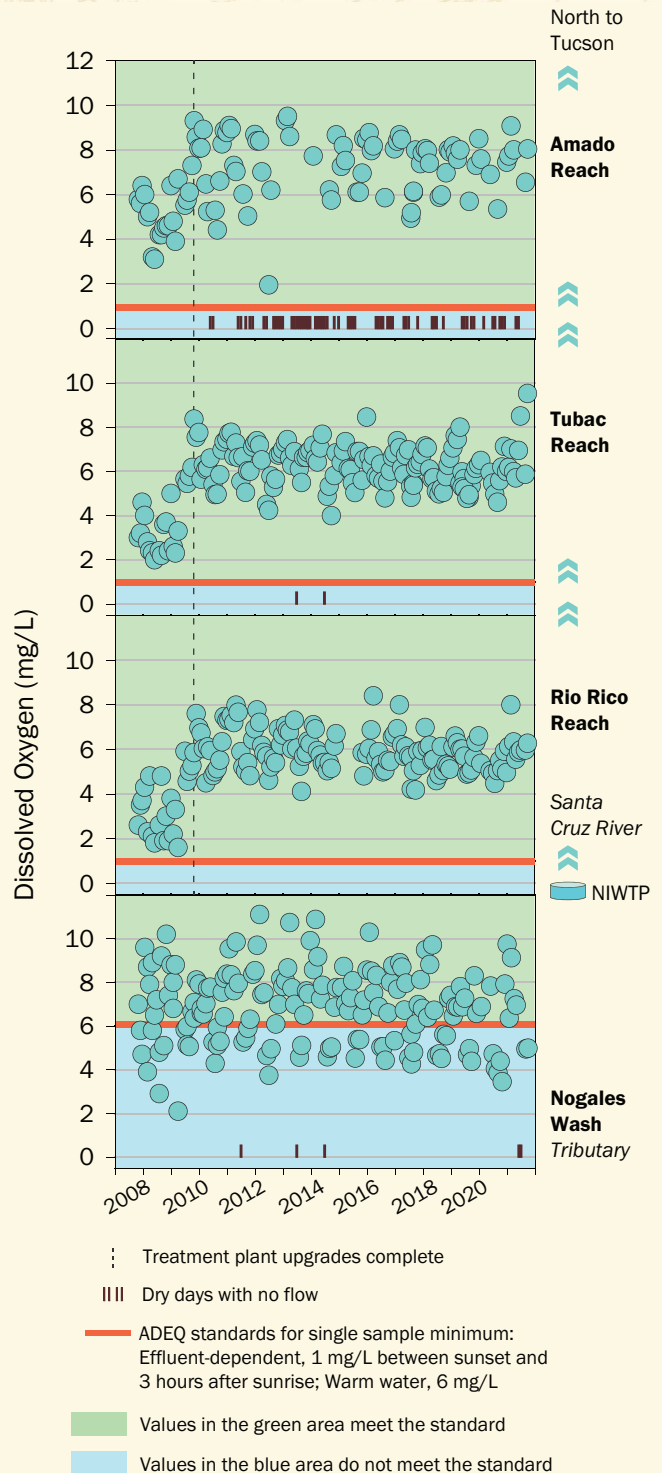
Levels of dissolved oxygen have met the standard in all three reaches of the Santa Cruz. Dissolved oxygen increased after upgrades to the treatment plant were completed in 2009. Although there have been more days with no flow in the Amado reach in recent years, when water is present, levels of dissolved oxygen have met the standard.

In Nogales Wash, levels of dissolved oxygen have been stable and 110 of 163 samples have met the warm water standard (they attained the standard 67% of the time). Treatment plant upgrades did not affect conditions in Nogales Wash.

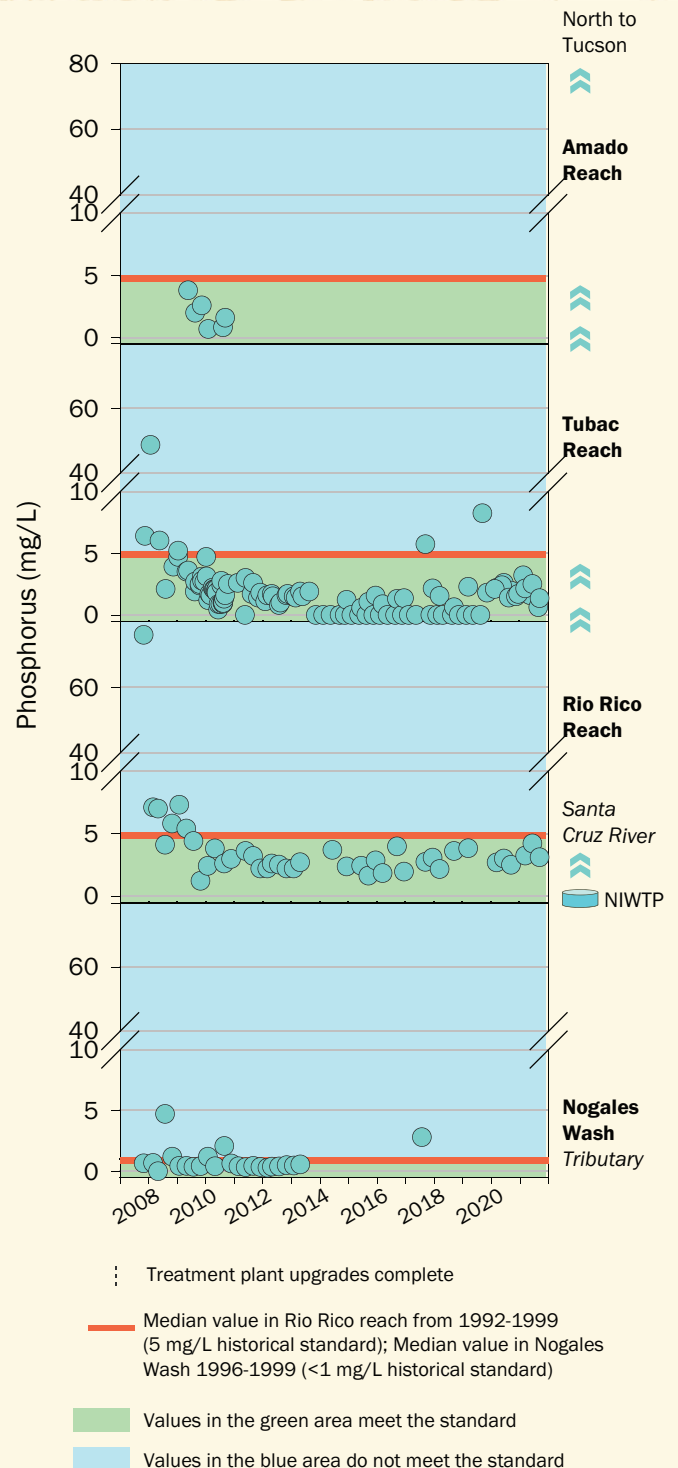
Phosphorus levels declined in the Rio Rico and Tubac reaches, most notably after the upgrades to the treatment plant were complete in 2009. Data are limited for the Amado reach but measures of total phosphorus are below the historical standard.

Nogales Wash has limited data and treatment plant upgrades did not impact conditions. All but five samples met the historical standard. The only sample since 2013 was taken in 2017 during a sewage breach when untreated wastewater was flowing out of the International Outfall Interceptor and into Nogales Wash.

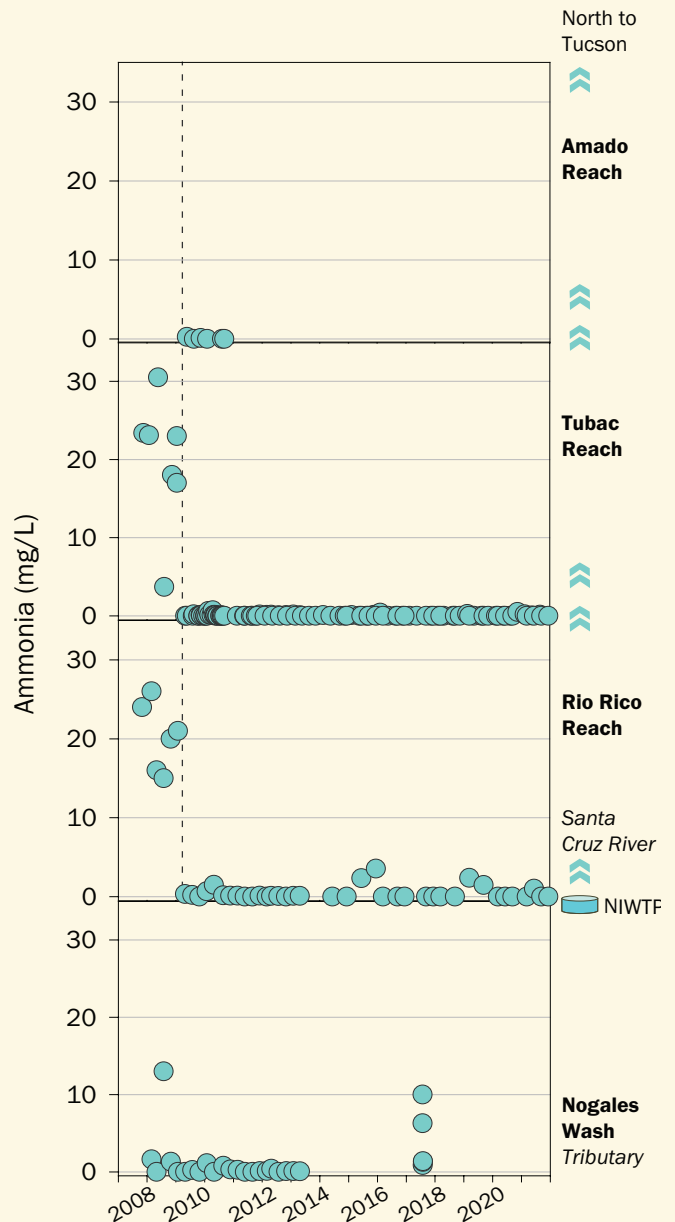
Ammonia decreased dramatically and was often not detected in the Rio Rico and Tubac reaches after the treatment plant upgrade was complete in 2009. This improved water quality led to beneficial conditions for fish and other aquatic wildlife. Although data are limited for the Amado reach during this period, between 2000 and 2007 measures of ammonia averaged 10 mg/L and followed a similar pattern to the Rio Rico and Tubac reaches. The decreased ammonia likely reduced the clogging effect in the river bed and was a factor in the reduced flow extent observed since 2009.

Since the treatment plant upgrade, only 5 of 128 sampling events have detected elevated ammonia levels that averaged 2.25 mg/L in the Rio Rico reach. Removal of ammonia is complex. The NIWTF uses a multi-step process that features alternating oxygenated and oxygen-free zones and must regularly optimize processes to maintain the delicate balance of oxygen needed for maximum ammonia removal.

Nogales Wash was not impacted by the upgrades to the treatment plant. Ammonia levels here were low, averaging 1.4 mg/L from 2008–2013. Measures of ammonia from 2017 were taken during a sewage breach when untreated wastewater was flowing out of the International Outfall Interceptor and into Nogales Wash.

∴ Treatment plant upgrades complete

Note - Ammonia standards vary with temperature and pH and can't be graphed as a single line.

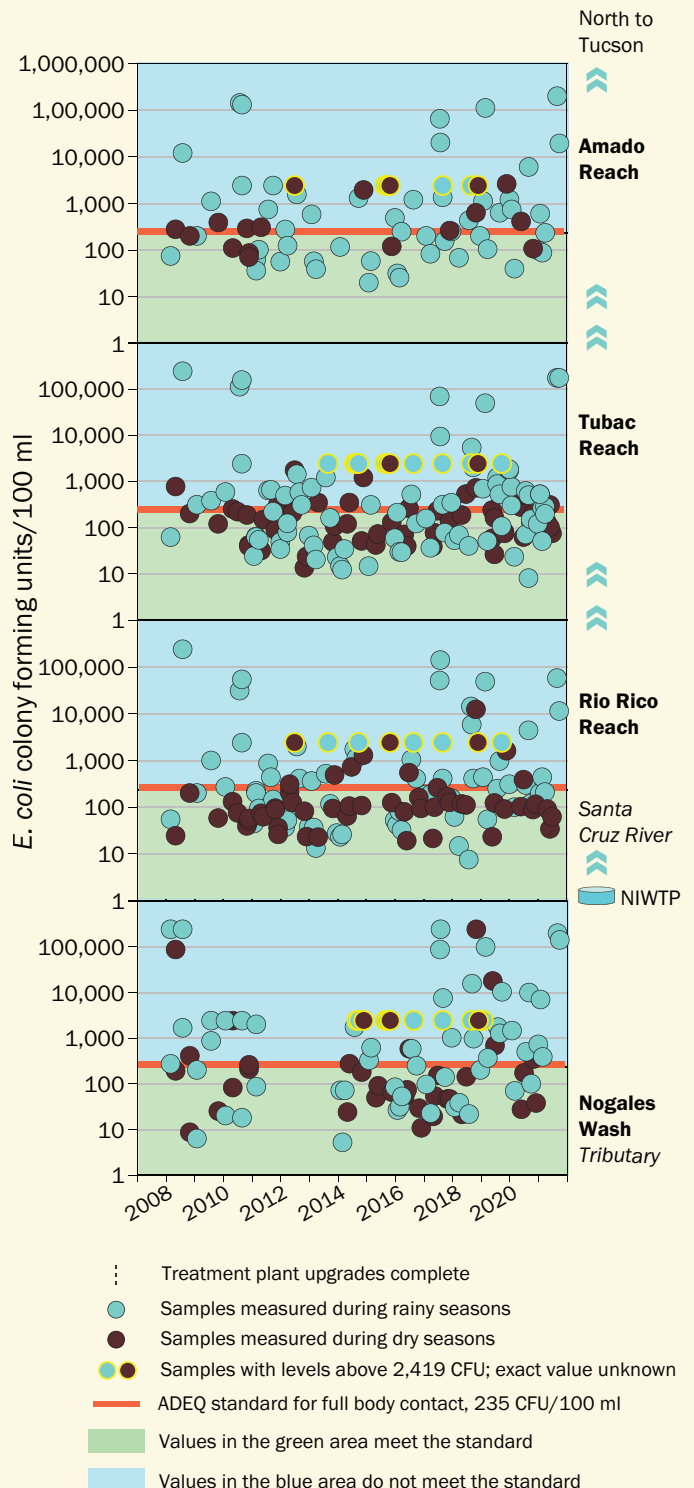
*E. coli* levels varied seasonally and were similar in all three reaches of the river and in Nogales Wash. The Nogales International Wastewater Treatment Plant has always treated for bacteria prior to release of effluent in the Santa Cruz, thus levels of *E. coli* in the effluent did not change after the upgrades were complete. Levels of *E. coli* in the river exceeded the standard most often during the rainy seasons. During the 2021 monsoon season, average *E. coli* for all sites combined was 131 times greater compared to average levels in the preceding 21 months (Oct 2019–June 2021).

High levels at all sites during the rainy season suggest that rain is washing fecal contamination into the river from multiple sources within the watershed. Research published in 2019 reported that microbial markers associated with humans and ruminants (sheep, goats, cattle, and deer) were the markers most frequently detected and were strongly correlated with flooding conditions.<sup>1</sup>

One source of *E. coli* contamination is the aging wastewater infrastructure along Nogales Wash. Several of the exceedances in Nogales Wash from 2017 were from samples taken during a sewage breach when untreated wastewater was flowing out of the International Outfall Interceptor and into Nogales Wash. Repairs began in 2022.

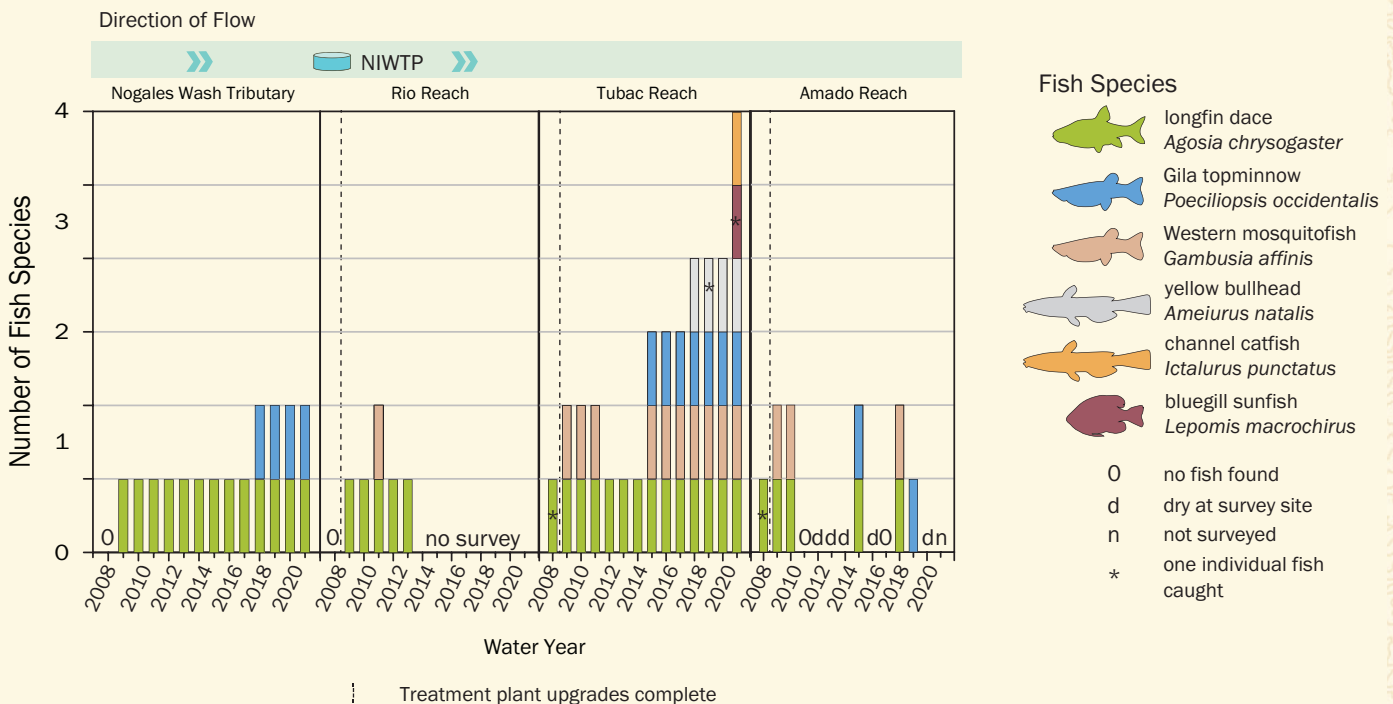
Annual fish surveys in the fall determine fish presence and species in Nogales Wash and at several locations downstream of the treatment plant. In 2008, only longfin dace were found, and in very low numbers (2 individual fish caught). After the treatment plant upgrade, the number of fish species increased from one to four (two native and two

non-native). The endangered Gila topminnow returned to the river in 2015 and the relative ease of capturing them during surveys suggests they are thriving. In 2021, two new non-native species were identified in the Tubac reach: the channel catfish (*Ictalurus punctatus*) and bluegill sunfish (*Lepomis macrochirus*). In addition, a hybrid of the native Gila topminnow (*Poeciliopsis occidentalis*) and the non-native headwater livebearer (*Poeciliopsis monacha*) of Mexico has recently been discovered. Further research is needed to determine the impact of the *Poeciliopsis occidentalis-monacha* hybrid on the endangered native. Conditions in the Amado reach have been occasionally dry at the time of survey and thus may no longer represent perennial habitat.

Though not affected by the treatment plant upgrade, Nogales Wash has also seen an increase in fish species, most notably with the return of the Gila topminnow in 2018. The *Poeciliopsis occidentalis-monacha* hybrid has been found here too. Though not included in this summary, longfin dace were found in Nogales Wash in 2007. The reason why no fish were found during the baseline year is unknown.

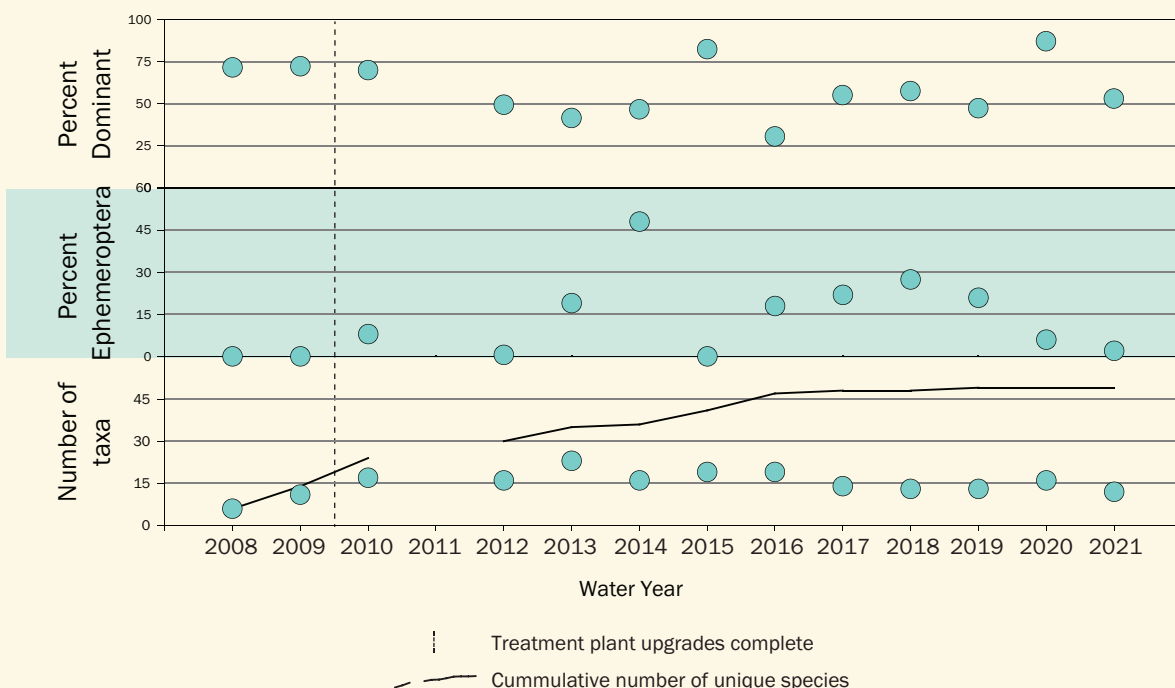
The percent of the community dominated by a single group has decreased, but still hovers around the 50% threshold. This suggests that the river is under environmental stress. The percent of the aquatic community comprised of pollution-sensitive Ephemeroptera increased after the treatment plant upgrade, suggesting improvements in aquatic conditions, but dropped again in 2020 and 2021. Furthermore, only 6 unique species were found in 2008. Since the upgrade, the number of unique species found increased to an annual average of 15 species. The cumulative number of unique species has also increased, reaching 49 by 2019. As only 2 new species have been found since 2016, the rate of increasing diversity may be slowing or reaching equilibrium.

Drier conditions and more variable flow in 2013 and 2014 may help explain some of the variability seen between 2013 and 2015. Further monitoring will be needed to determine if the aquatic invertebrate community will continue to improve.

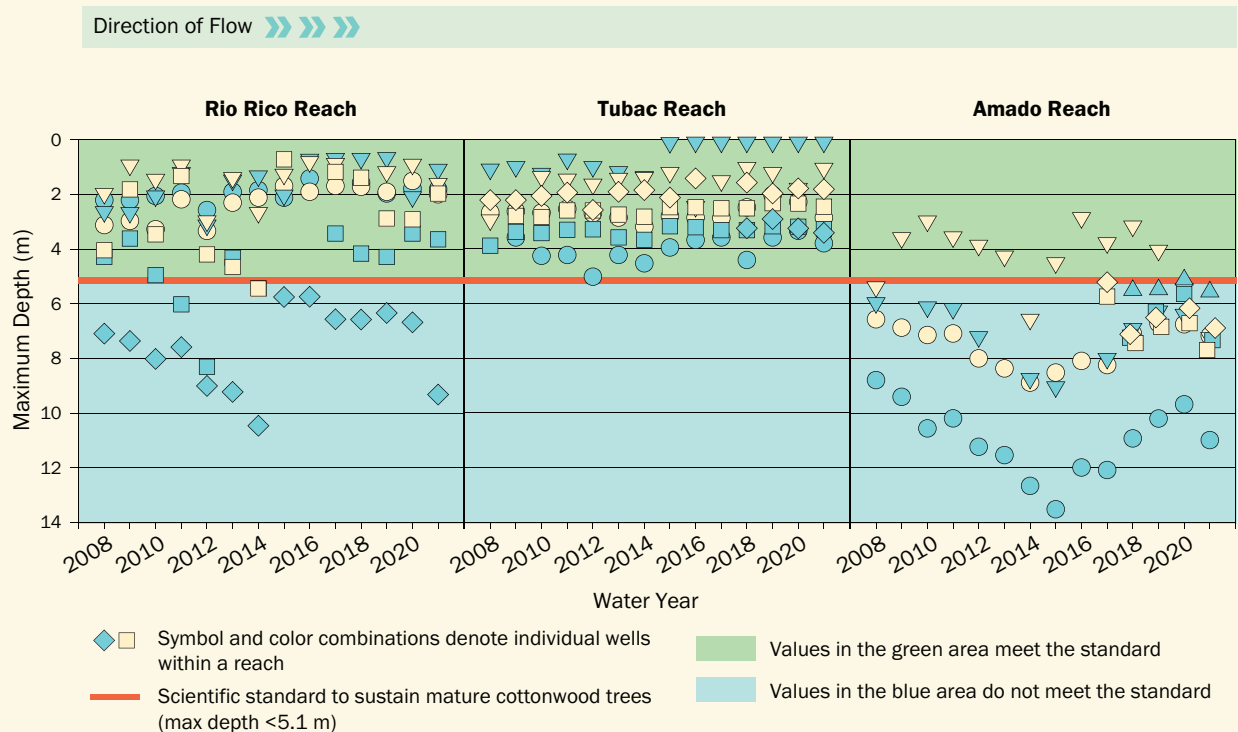
The number of depth measurements over the years has varied by well. Some wells were measured only once a year, while others were measured daily. All depth to groundwater measurements are determined relative to depths that may support cottonwoods. The Tubac reach appears to have the most stable depth to groundwater measures. Rio Rico and Amado had shallower depths recorded in recent years, suggesting increased recharge.

In Rio Rico, the wells with measurements below the standard are located near the beginning of the reach, representing wells closest to the release of effluent. In contrast, several wells in the Amado reach that were below the standard are located at the far end of the reach and represent wells that are furthest away from the release of effluent. The best conditions for supporting cottonwoods may be along the Tubac reach where geologic and hydrologic conditions are optimal and the recharge of effluent is possibly highest.

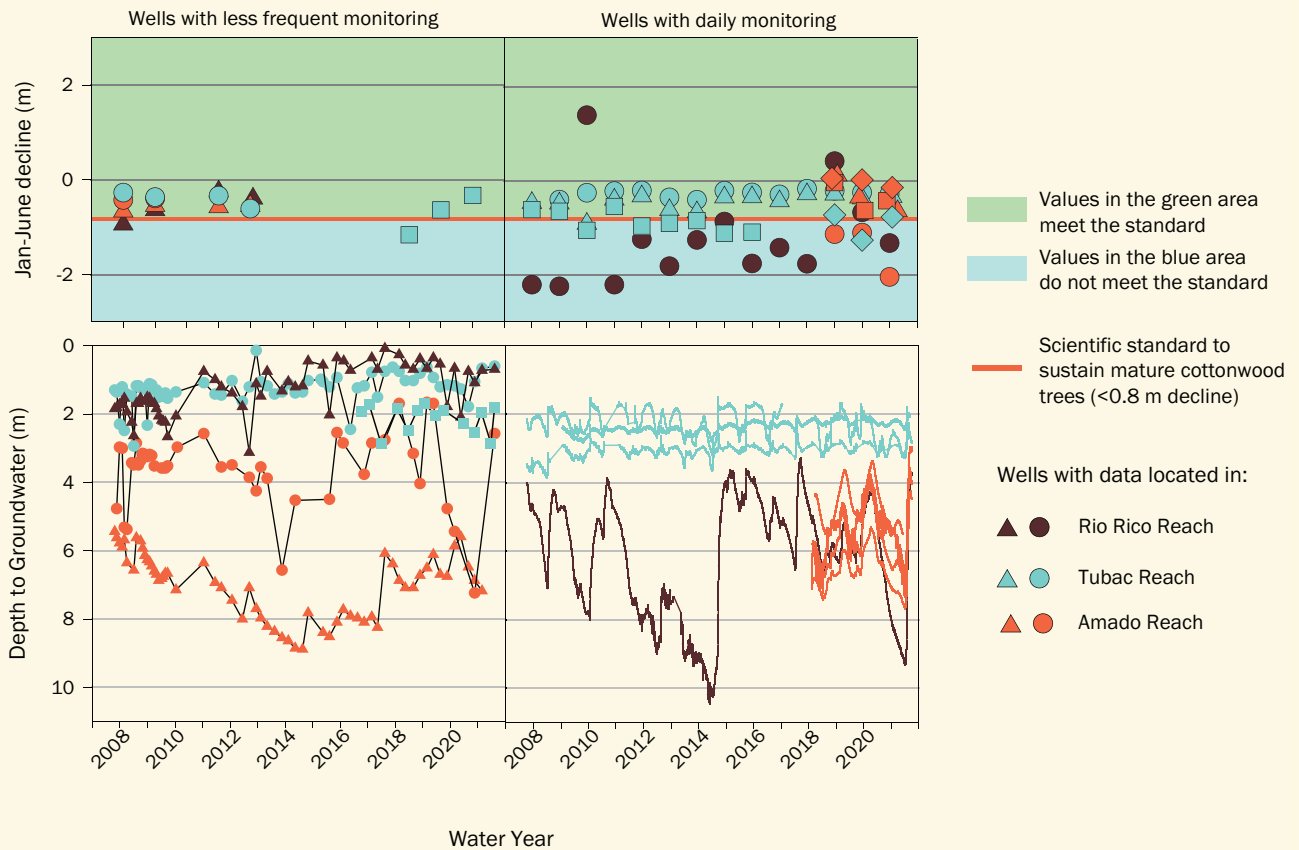
Rio Rico depths to groundwater varied between two wells. The well with less frequent monitoring is close to the Tubac reach and met the standard. The Rio Rico well with daily monitoring is near the effluent release and has greater fluctuations in water levels, often failing to meet the decline standard.

Although wells in Amado often met the standard, overall depth to groundwater may not support cottonwoods. Sonoran Institute launched a groundwater monitoring program in the Amado reach in 2018 that is providing additional data on groundwater levels.
